Accident
Investigation Board
Norway

REPORT

Marine 2020/02

REPORT ON OCCUPATIONAL ACCIDENT ON BOARD THE FACTORY TRAWLER NORDSTAR ON 10 JUNE 2018

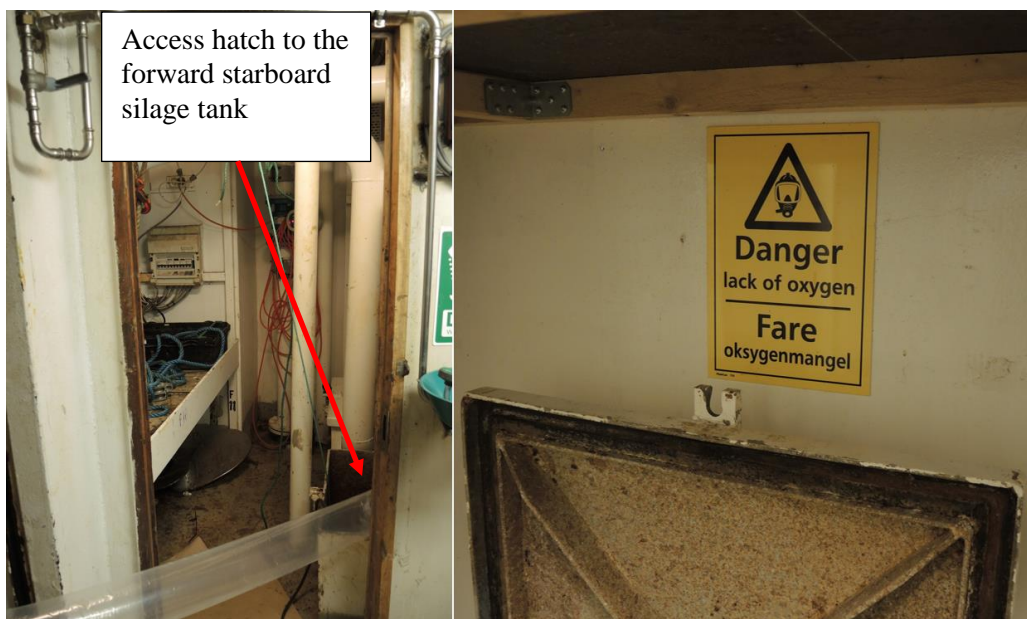
Figure 4: The access hatches for the two forward silage tanks were located forward of the factory, inside a confined space in the vessel's interior. There was a sign above the hatches with the text 'Danger lack of oxygen'. Photo: AIBN

The investigation has shown that the risk of gas being formed during the production and storage of silage had not been identified as a hazard in the shipping company's safety management system. Neither risk assessments nor checklists or operating procedures made any mention of the hazards associated with gas formation. The hatches to the silage tanks were marked 'Danger – lack of oxygen', but not as a gas hazard.

Following the accident, Nordstar has conducted a risk assessment of the silage production, also including factors relating to the hazards that work in storage tanks entails. A procedure for cleaning silage tanks has been added to the safety management system, and the checklist for tank entry has been updated. The shipping company has also stated that information about the risks associated with silage production and storage will be covered at regular safety meetings on board the vessel. The tanks are now secured by padlocks, the keys to which are kept on the bridge. In addition, the tanks are marked with warnings of gas hazards in the tank.

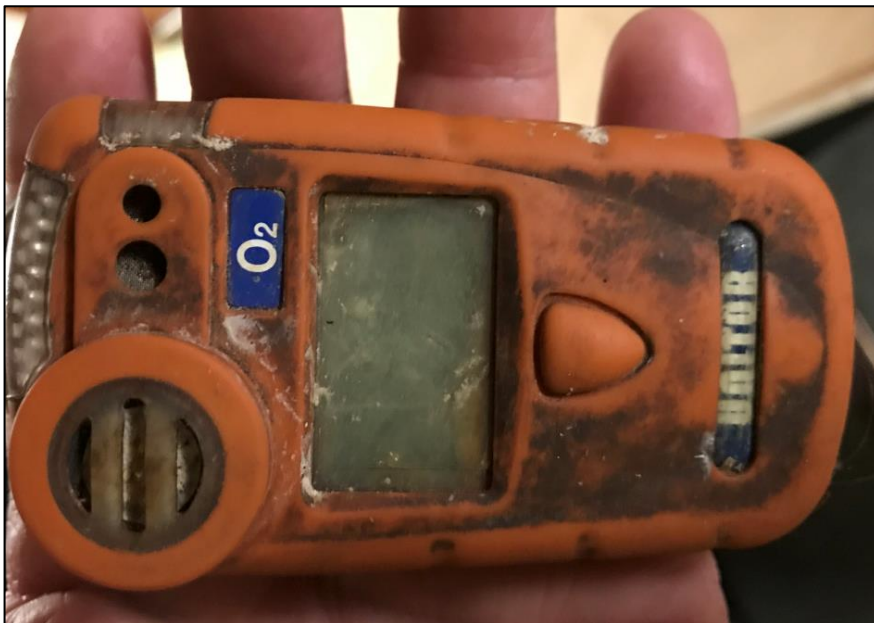
Figure 5: The oxygen detector in use at the time of the accident was of the type Unitor OXY-MATE C. Photo: AIBN

The fisherman, who was wearing a personal oxygen detector, decided to enter the tank to set up the fan, since the O₂ measurement did not show that there was insufficient oxygen inside the tank. The fisherman probably knew too little about the risk of hazardous gas forming in the tank over time. The silage tanks were normally cleaned by the crew departing on a new voyage, which meant that it was not normal for silage and bone residue to remain in the tanks over time. However, since they were not going to produce silage on the voyage in question, the tanks had not been cleaned prior to departure. Risks associated with the decomposition of silage and bone residue in the tanks, and thereby the formation of hazardous gases such as hydrogen sulphide and methane, were therefore not something Nordstar's crew had experience of.

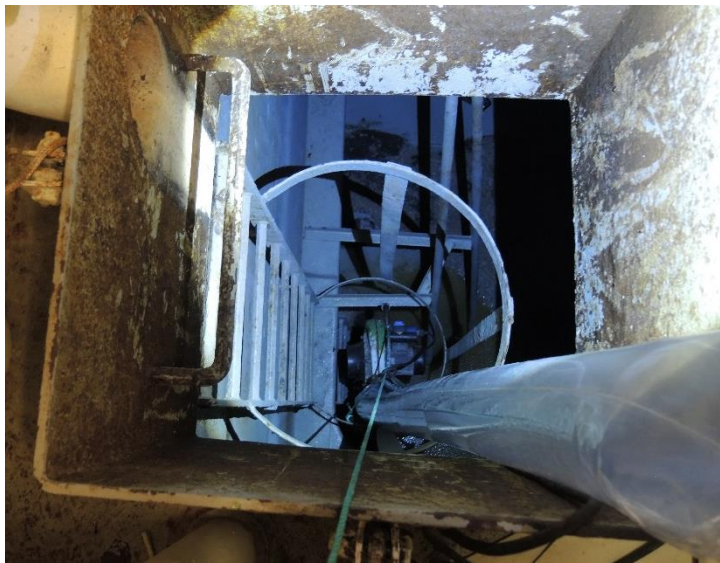
It was also very challenging that the ladder cage on the entry ladder obstructed the hoisting operation (Figure 6). Another 20 minutes passed before they finally managed to get the injured person out of the tank.

*Figure 6: The ladder cage on the ladder in the silage tank obstructed the hoisting operation.
Photo: AIBN*

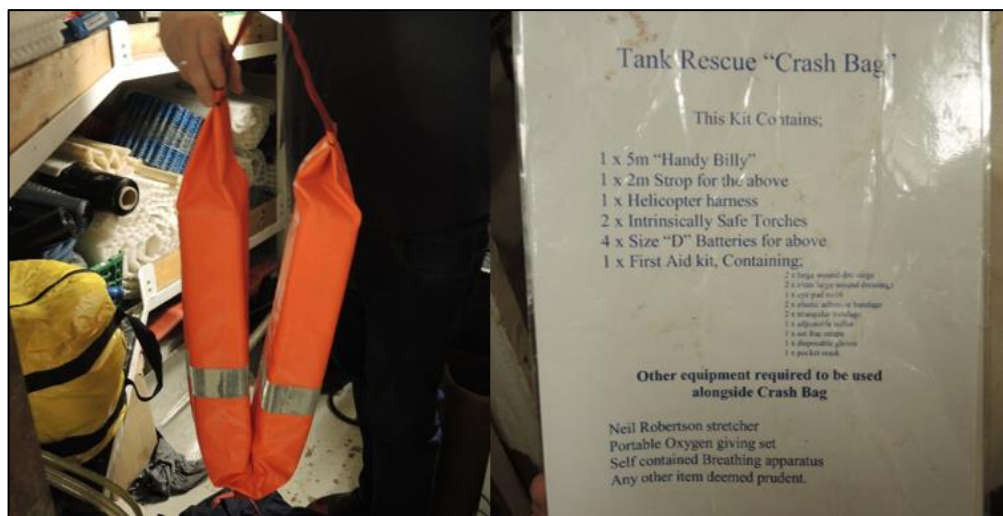
Figure 8: The rescue equipment included a lifting strop. The equipment was kept in a storeroom by the entrance to the forward starboard silage tank. Photo: AIBN

There was no lifting eye in the ceiling above the silage tank's access hatches. On the day of the accident, the crew therefore used extra rope and pipes in the room where the hatches were located to attach the hoisting equipment.

- Better and more informative signs on tanks about the risk of gas forming in the tank.
- The shipping company has purchased fall protection equipment adapted for tank rescue, and equipment to enable more efficient rescues from tanks. It is also stated in the risk assessment that everyone who enters the silage tanks must wear fall protection equipment.

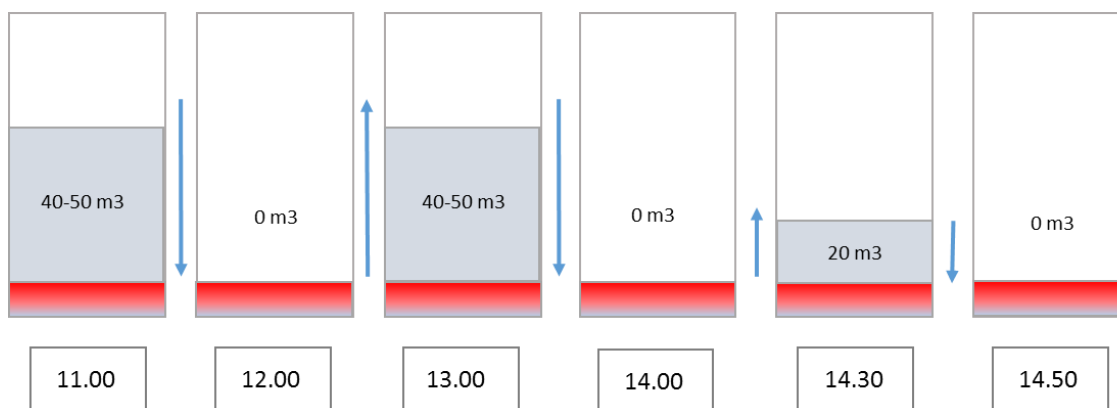
On the day of the accident, the work on flushing the tank started at about 11.00. There is some uncertainty about how much water was in the tank when the process of emptying it began. The figure below shows the assumed water content and times when the tank was filled and emptied. The oxygen content of the atmosphere in the tank was checked approx. 10 minutes after the tank was last emptied. Both the permanent ventilation pipes and the access hatch to the tank remained open throughout the emptying and filling period.

Figure 10: The process of flushing the tank began at 11.00 and was completed at approx. 14.50. Seawater is illustrated in blue and the sediment in red. The illustration is not to scale and gives an indication of the flushing process. Illustration: AIBN

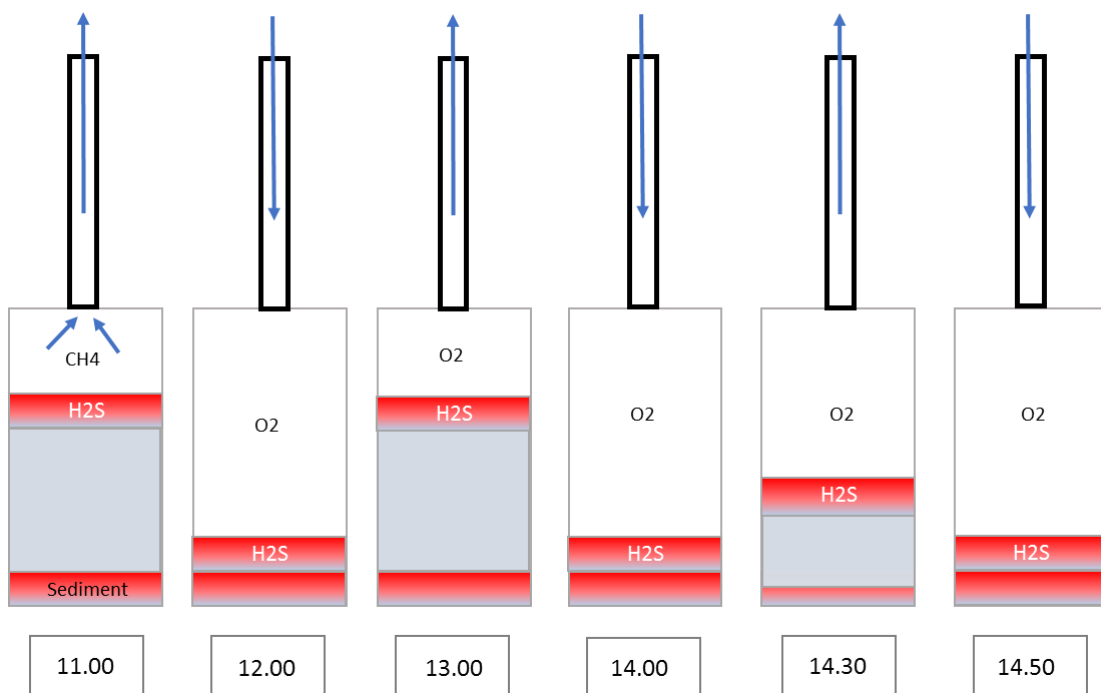
Because the tanks were not completely filled up with seawater, the free H₂S gas that settled on top of the seawater did not disappear, see the illustration of the possible tank atmosphere conditions in Figure 11. Since H₂S gas is heavier than air, it is also likely to have remained encapsulated in the silage residue. It is also probable that, when the fisherman stepped down into the bottom of the tank, the pockets of H₂S gas in the silage residue were released, rapidly exposing him to the gas.

The decomposition process has most likely taken place over a long period from May to June, and a high concentration of H₂S has probably developed in the silage residue. This probably caused immediately fatal exposure. The crew that went down the tank during the rescue operation wore breathing apparatuses.

Figure 11: Illustration of possible tank atmosphere conditions during the flushing process. The illustration is not to scale and gives an indication of the probable tank atmosphere conditions. Illustration: AIBN

- A procedure for cleaning silage tanks has been drawn up. Among other things, it describes how to fill the tanks in preparation for cleaning. The procedure also describes hazardous conditions that can arise in the tank, and it refers to both the procedure and the checklist for entering an enclosed space. Reference is also made to a separate risk assessment for silage production. Among other things, it states that fans should not be lowered into tanks due to the risk of explosion.
