# The lifeboat imbroglio

## Captain Paul Drouin MNI

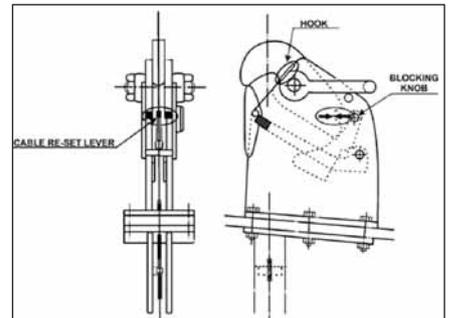
▲ Figure 2: Imbroglio? 'An intricate and confusing situation': Diagram from Transportation Safety Board of Canada report M00W0265 - *Pacmonarch*

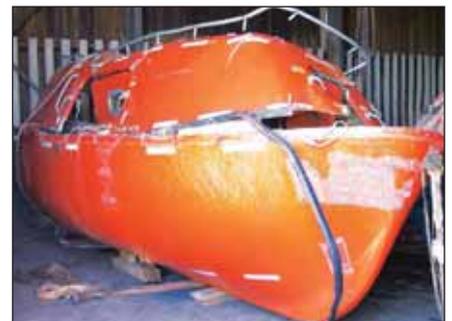
▲ Figure 3: Imbroglio 'A confused heap or tangle'.  
Photo from Australian Transport Safety Bureau report 208 – *Lowlands Grace*

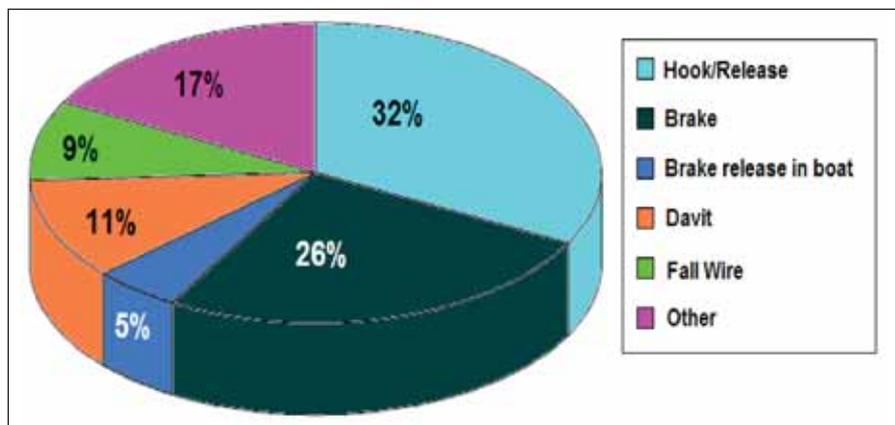
related to the hook/release gear as seen in Table 1, opposite page.

▲ Table 1: Component failure: from OCIMF survey, 1994

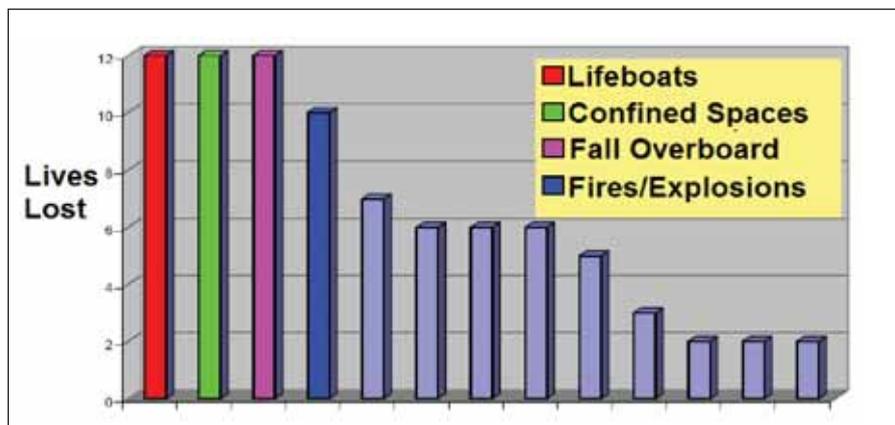
The UK MAIB Safety Study of 2001 on lifeboat and launching systems accidents added further weight to the existing body of knowledge; something was terribly wrong with the safety of lifeboats: see Table 2. This report studied UK statistics between 1989 and 1999. Accident statistics for this period show lifeboats and their launching systems cost the lives of 12 professional seafarers, or 16 per cent of the total lives lost on merchant ships within the the UK database. Eighty-seven people were injured. These accidents all occurred during training exercises or testing, with experienced and qualified seafarers performing, or supervising, the operations.

This same study found that the root cause of many of the accidents was the over-complicated design of the lifeboat launch system and its component parts, which in turn required extensive training to operate. It identified that training, repair and maintenance procedures fell short of what was necessary, and that there were extensive problems with manufacture, construction, maintenance and operation.

▲ Table 2: Causes of accidents from MAIB 2001 safety study on lifeboats and launching systems accidents
