Report of safety investigation

LIFEBOAT ACCIDENT

CMA CGM

ON 15 APRIL 2011

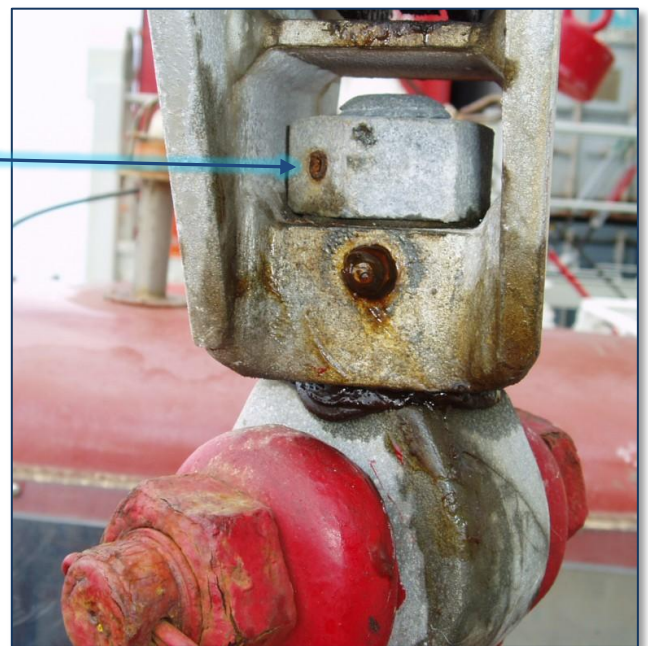
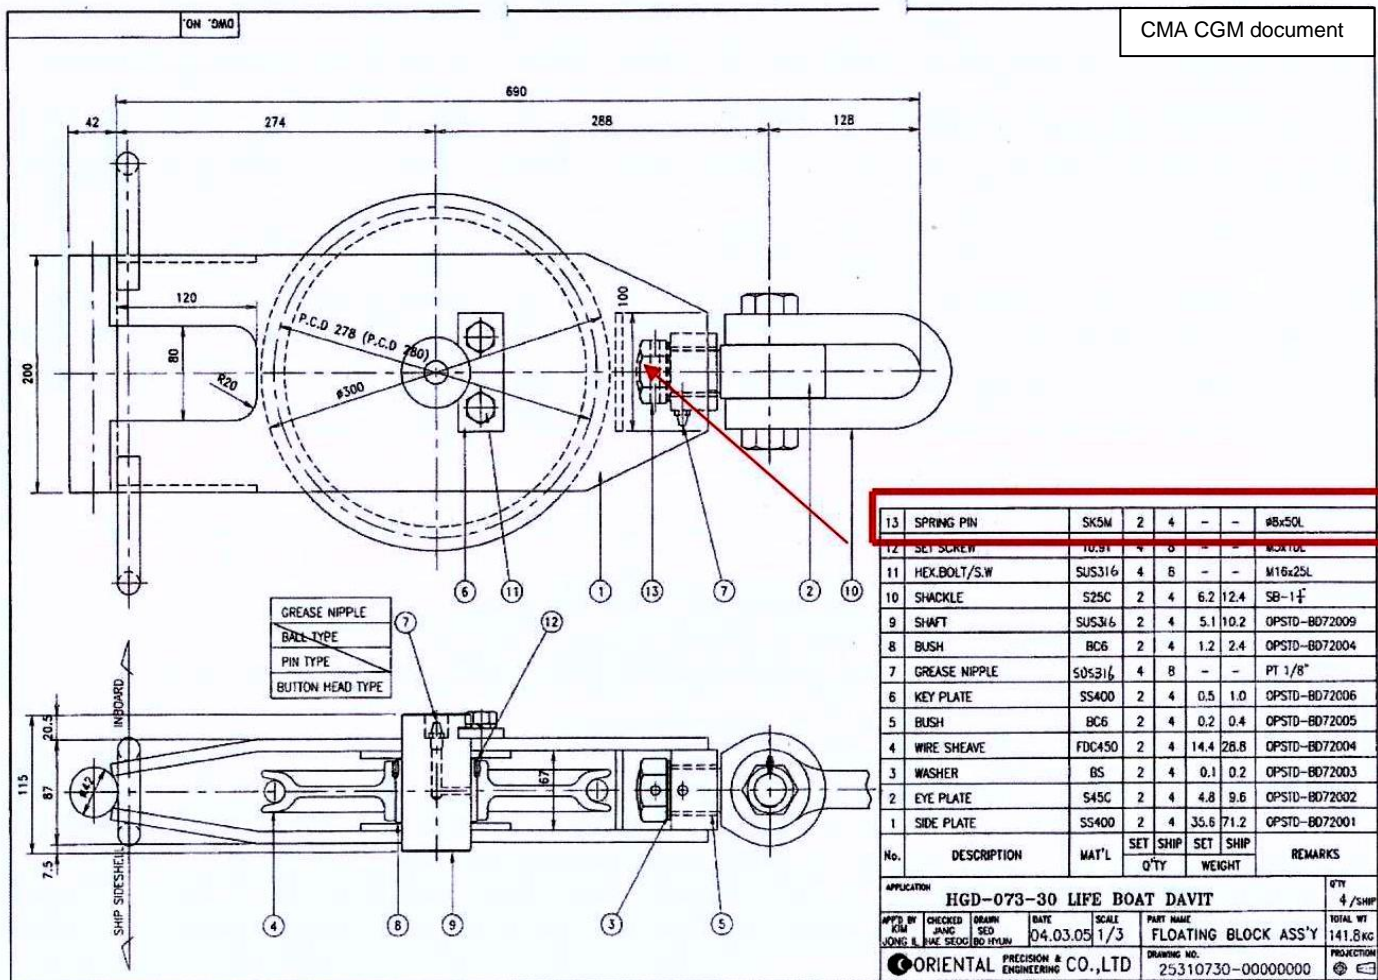
Missing pin

The lack of a spring pin on the swivel screw nut had allowed it to unscrew then to disconnect from the release hook connecting parts.

The survey done after the accident, on board other vessels of the company, shows that even if in some cases the nut safety pin is blocked by a mixture of grease and rust, it is never missing. This pin, tapped in its drilling at the time of the pulley block assembly, can only be removed by using a drift punch.

This tends to prove that the pin would not have been put in place during the pulley block assembly operations, at the time of the construction of the vessel, all the more so no maintenance operation, including a swivel dismantling had been recorded in the vessel historical data.

The missing pin, probably since the construction, is the **causal factor** of the accident.

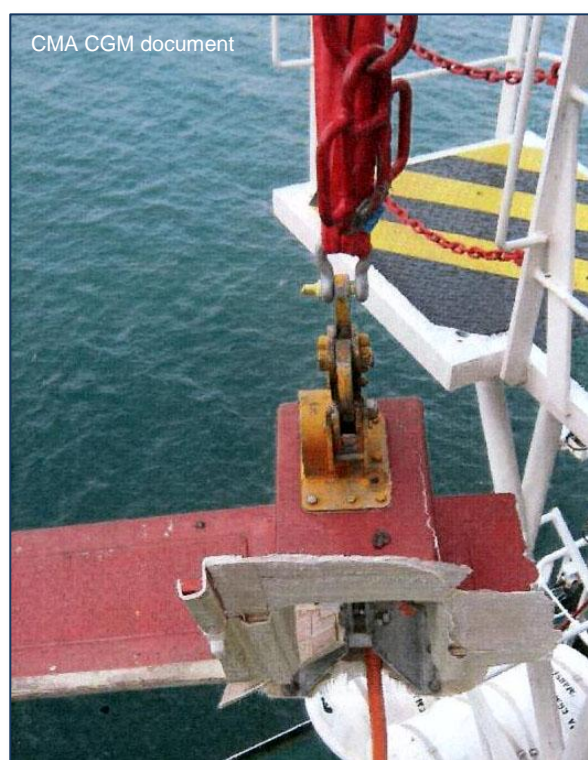
The lifeboat structure

The structure connected to the hull on which the aft release hook is locked (sling plate, deadwood) had been torn when the bow had been disabled. This shows that this situation, admittedly unlikely, but which cannot obviously be ruled out, had not been considered at the time of the design of the boat.

In these conditions, with her structure too weak to hold her own weight and her crew's, even with only few people aboard, on only one hook, the boat (although built according to the current regulation) do not act as a protection cell at all, as long as she is not floating normally.

The weakness of the structure is an **aggravating factor** of the consequences of the accident. The break and the consequent fall have deprived the crew of a chance for survival.

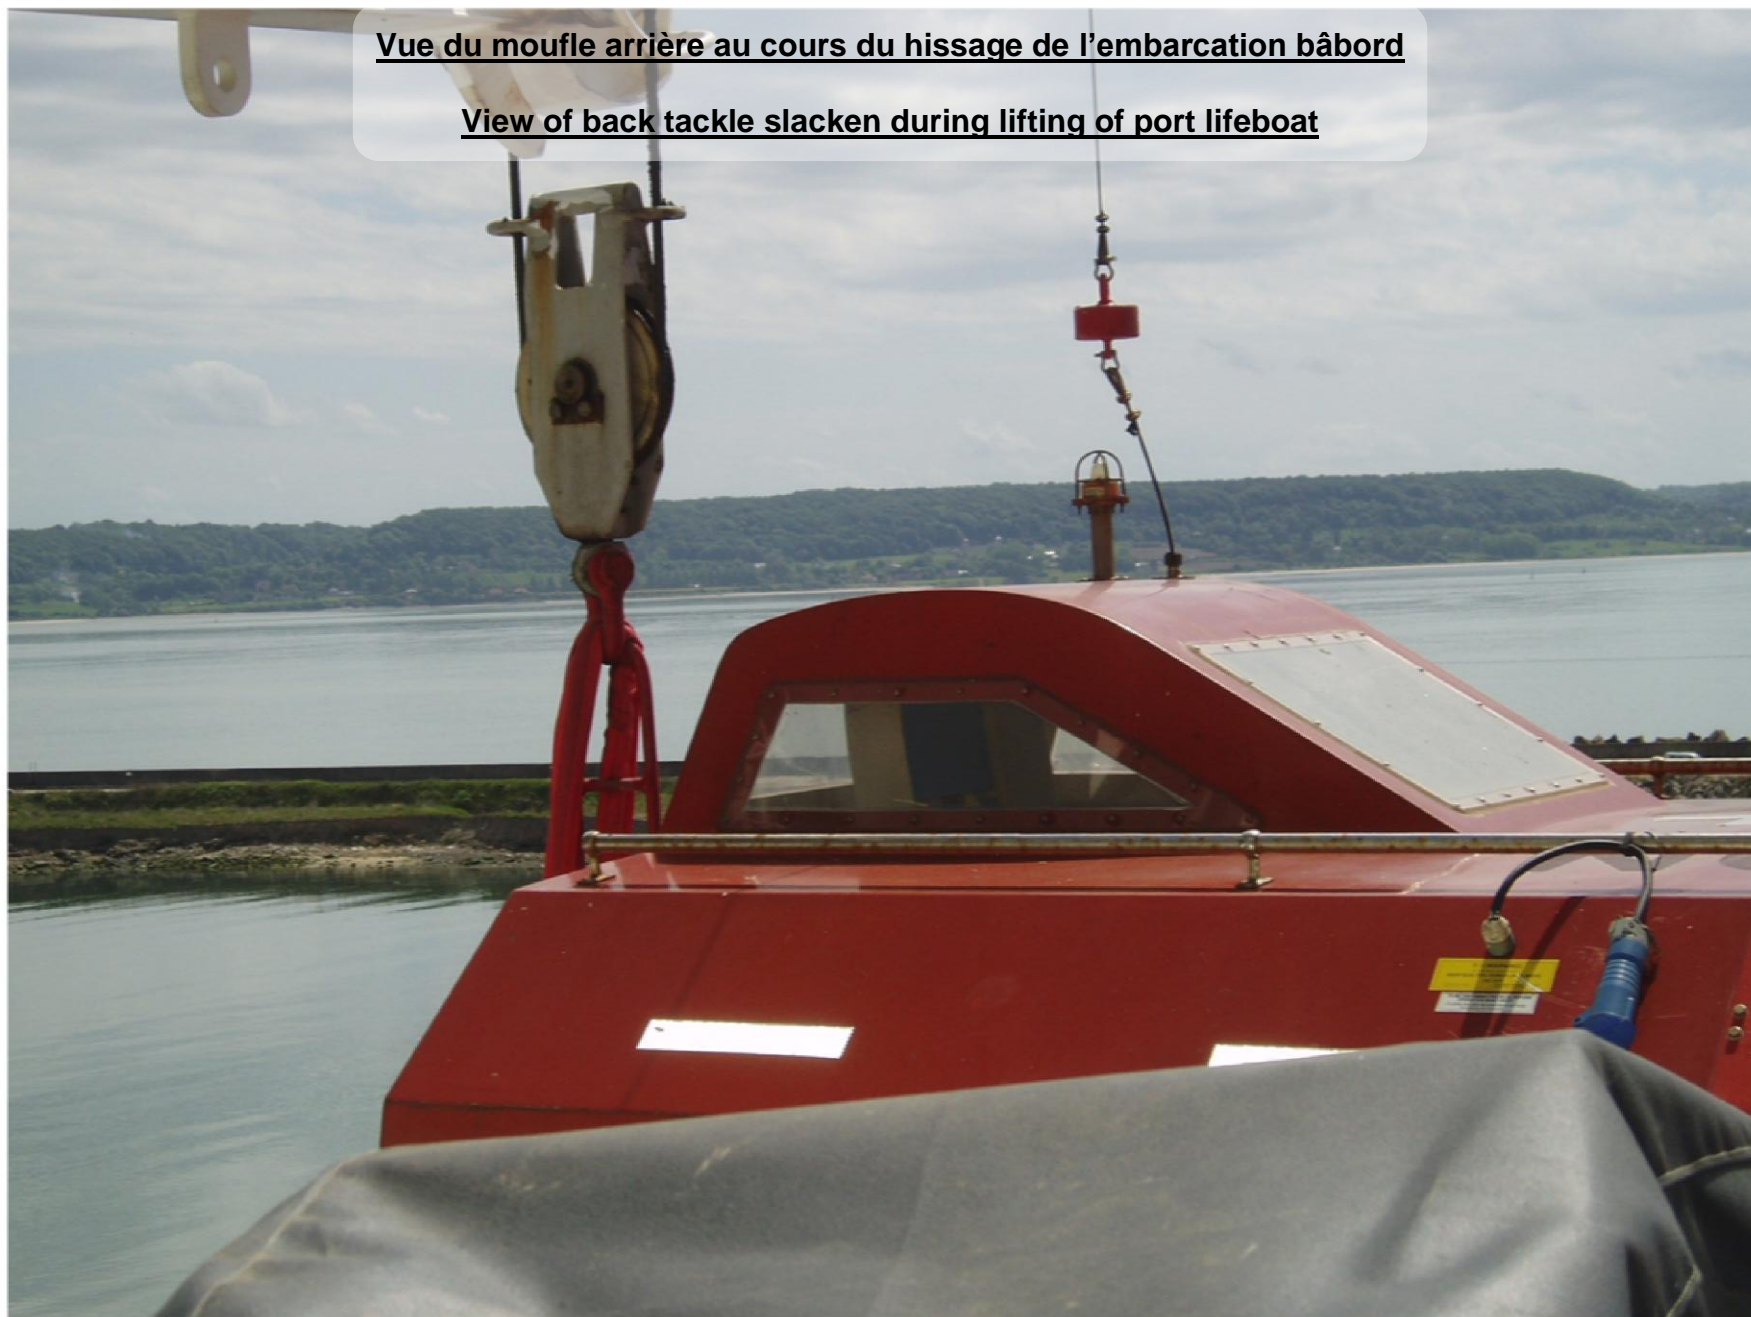
Vue du moufle arrière au cours du hissage de l'embarcation bâbord

View of back tackle slacken during lifting of port lifeboat

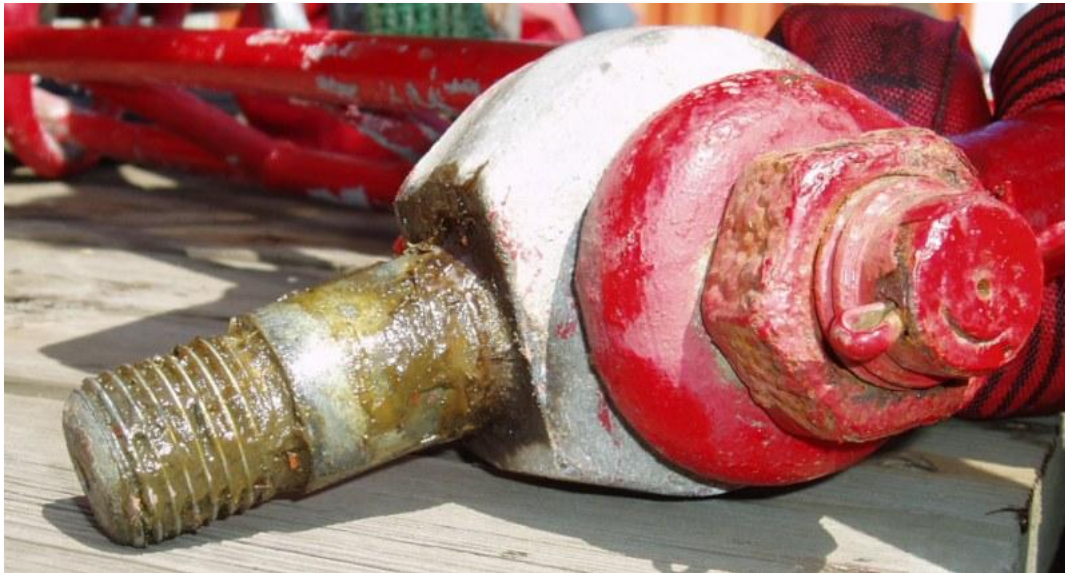
Ceinture de liaison entre émerillon et croc de largage
(Fall Protection Device)

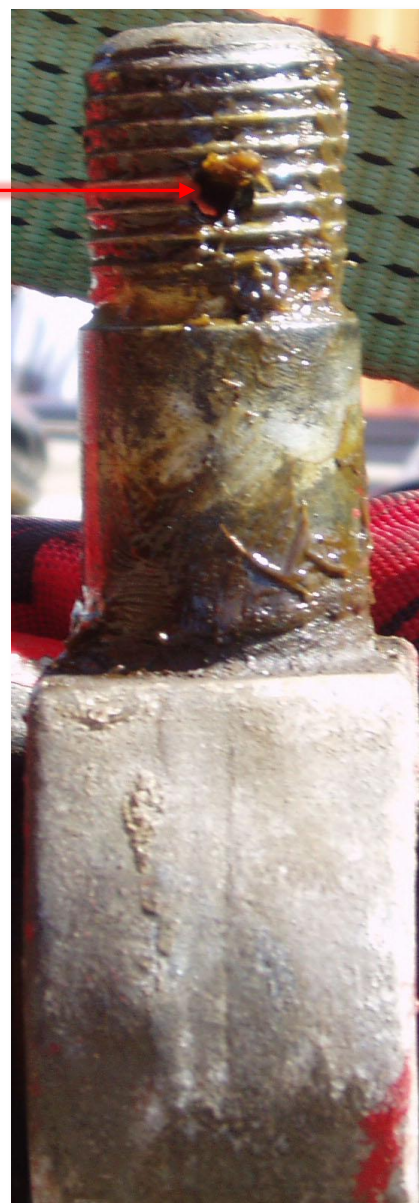
Vis de l'émérillon tribord après l'accident / Starboard swivel screw after the accident

Perçage pour goupille
drilling for pin
