MEMBER ALERT

OCTOBER 26, 2016

GOVERNMENT CLAMPDOWN ON MINING ACTIVITY AND HEAVY RAIN IN THE PHILIPPINES AFFECTING NICKEL ORE SHIPMENTS.

WARNING OF WET NICKEL ORE CARGO IN BULK FROM SURIGAO PHILIPPINES

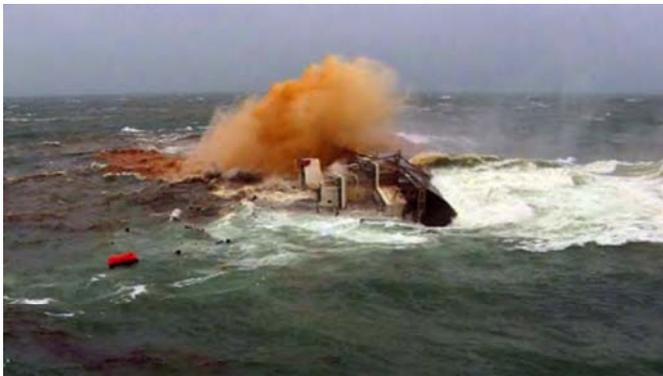
The consequences of a nickel ore cargo liquefying can be catastrophic

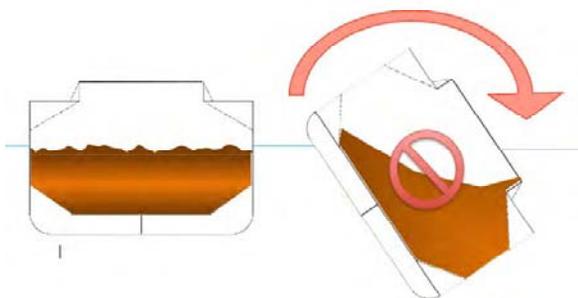
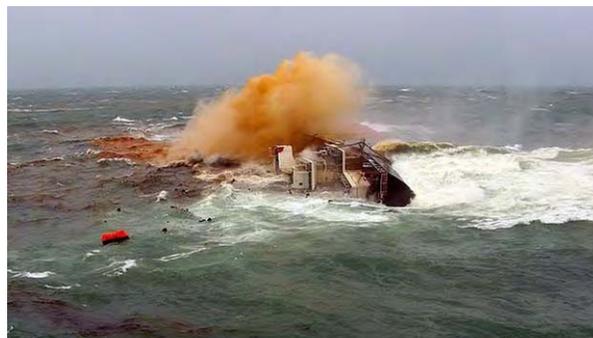
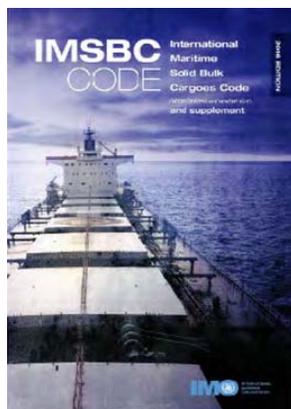
Nickel ore, when the moisture content is above the TML, (Transportable Moisture Limit) the cargo can liquefy with catastrophic results. The liquefaction of a nickel ore cargo is not like free-surface effect of a liquid but is when due to vibration and movement a solid now acts like a liquid, it is a dynamic shift. The effects of liquefaction is so dramatic that in discussions with sole survivors off two vessels we undertook search and rescue in the South China sea, the vessels rolled over and capsized in less than 30 seconds.

A picture speaks a thousand words;

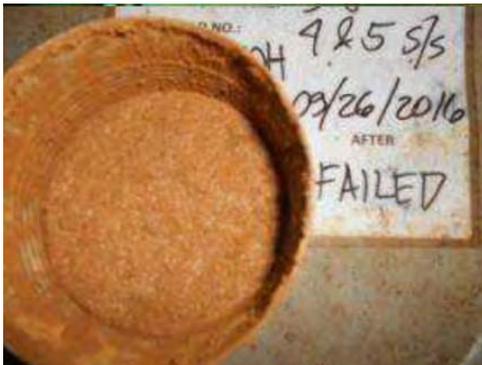
This is a simple test and as the term implies (can test) a metal can is suitable, such as a coffee tin, paint tin (but must be clean). Take about 1 to 2 kg of the ore and place it in the tin, repeatedly slam the can the bulk code says 25 times, **if the ore remains the same** then there are no obvious signs of moisture, if it shows any signs of liquefying (**very obvious will be where free water appears on top or takes on a shiny flat appearance**) then the cargo should be **rejected and not loaded**.

A failed test – flat pancake appearance- - FAIL carry out laboratory analysis of cargo

A can test **should never be used as a basis alone to determine if a cargo is safe to load**, a can-test is a rudimentary field test to try and observe if there is obvious signs of moisture, it is not a method for loading a vessel. The only way to determine a cargo meets the IMSBC is through a laboratory analysis. Even cargo that can show no obvious signs of moisture in a can test will still fail an analysis when observed to Plasticise (see below) or Splatter, as for this to occur the cargo is already beyond its FMP. Can tests have become even more unreliable in the Surigao area because of the high clay content of the nickel ore.

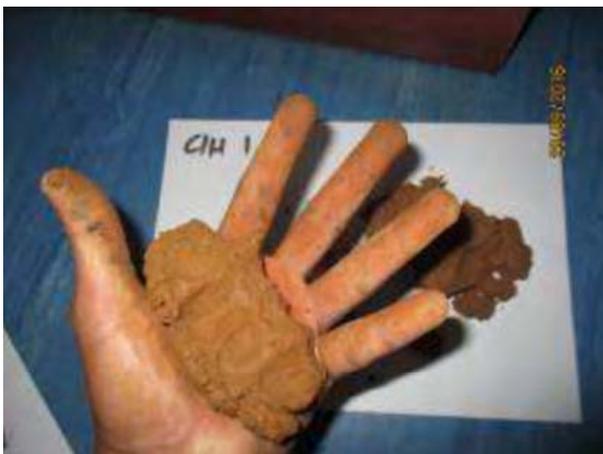
This is when a sample of cargo is placed in the hand, the sample is compressed, if on opening the hand the sample retains its shape this is evidence of High moisture – FAIL carry out laboratory analysis of cargo

When a sample can be molded and retains a shape we say it has “Plasticised”, to have the ability to do this then moisture must be present.

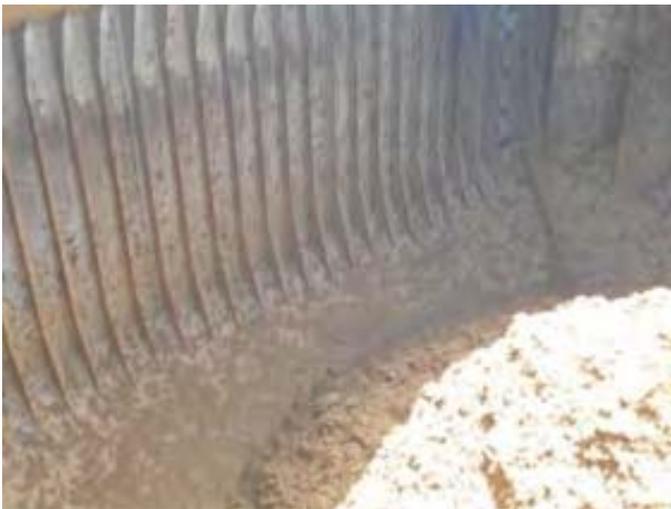
Any sign of splatter in the hold, large or small this indicates high moisture – FAIL - carry out laboratory analysis of cargo
