Using a Pilot Laptop with the AIS pilot plug - observed errors and difficulties

2nd November 2008

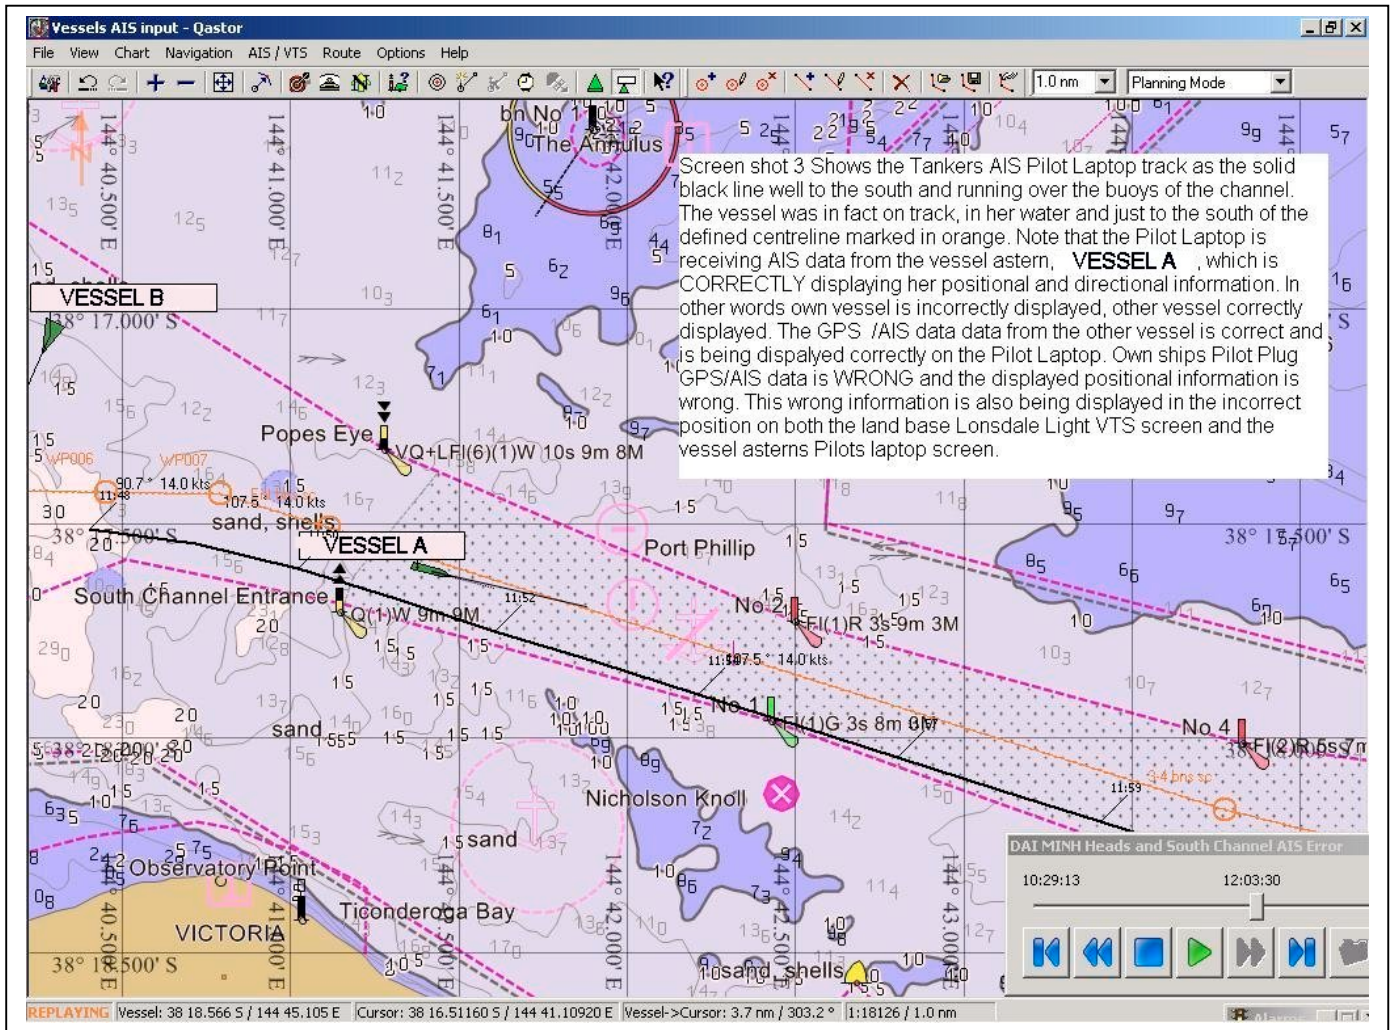
Image 3 – wrong datum being used in own vessel’s main GNSS receiver.

The screenshot below shows the effect of the wrong chart datum being used in the vessel’s main GNSS receiver. See Pilot’s comments on the screenshot itself.

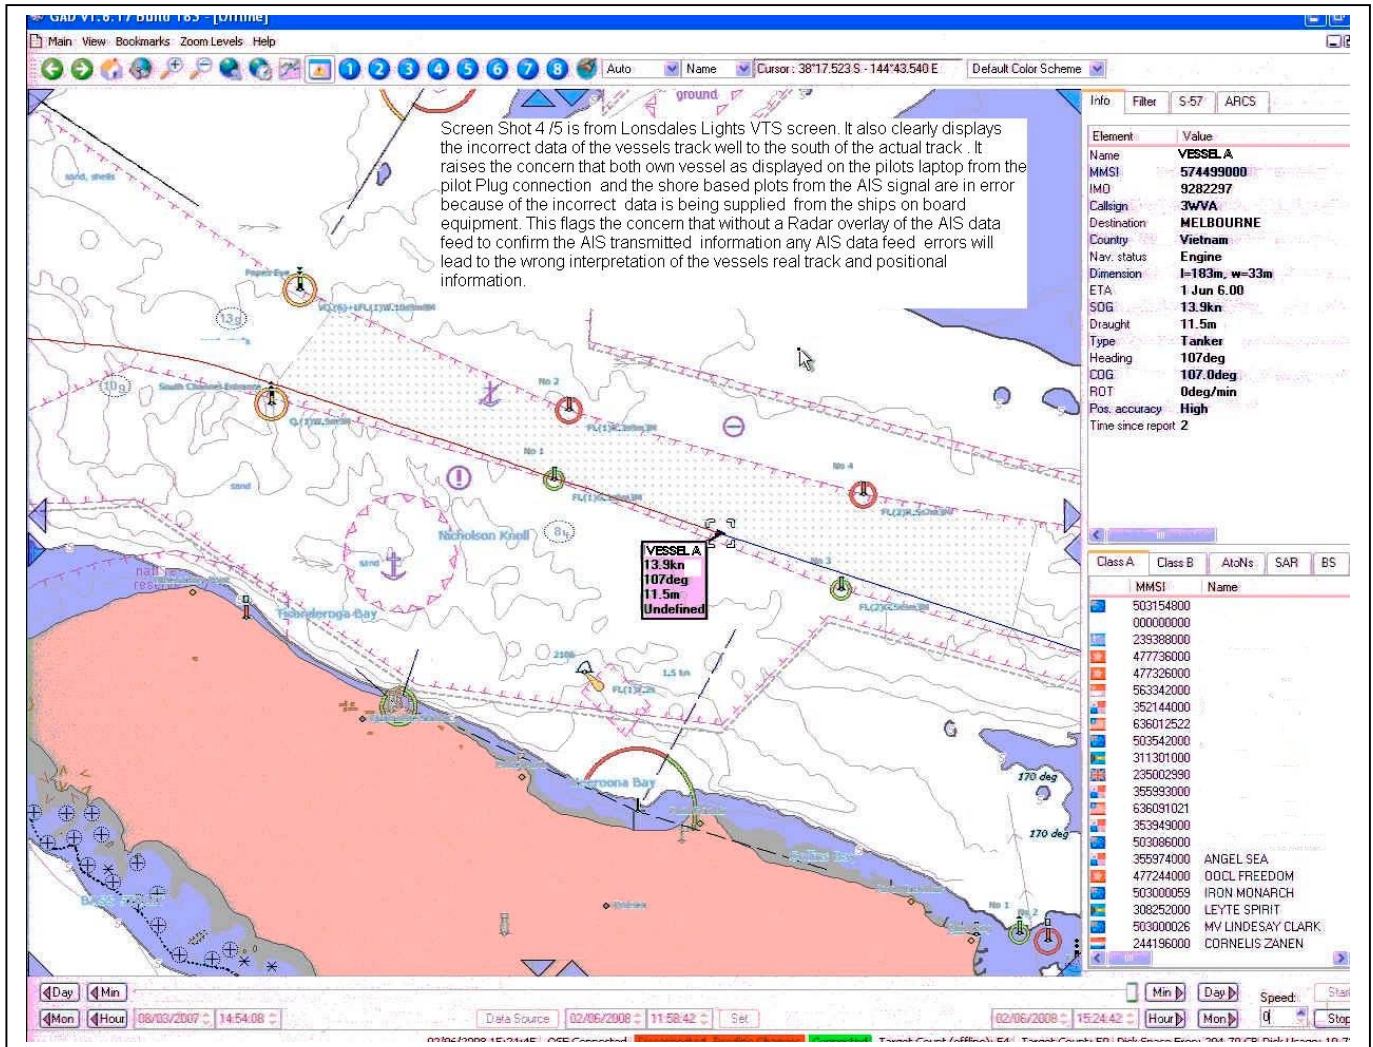
Image 4 – wrong datum being used in own vessel’s main GNSS receiver (shown on shore display).

The screenshot below shows the effect of the wrong chart datum being used in the vessel’s main GNSS receiver. The incorrect position is also being displayed on the shore based AIS traffic display. See Pilot’s comments on the screenshot itself.

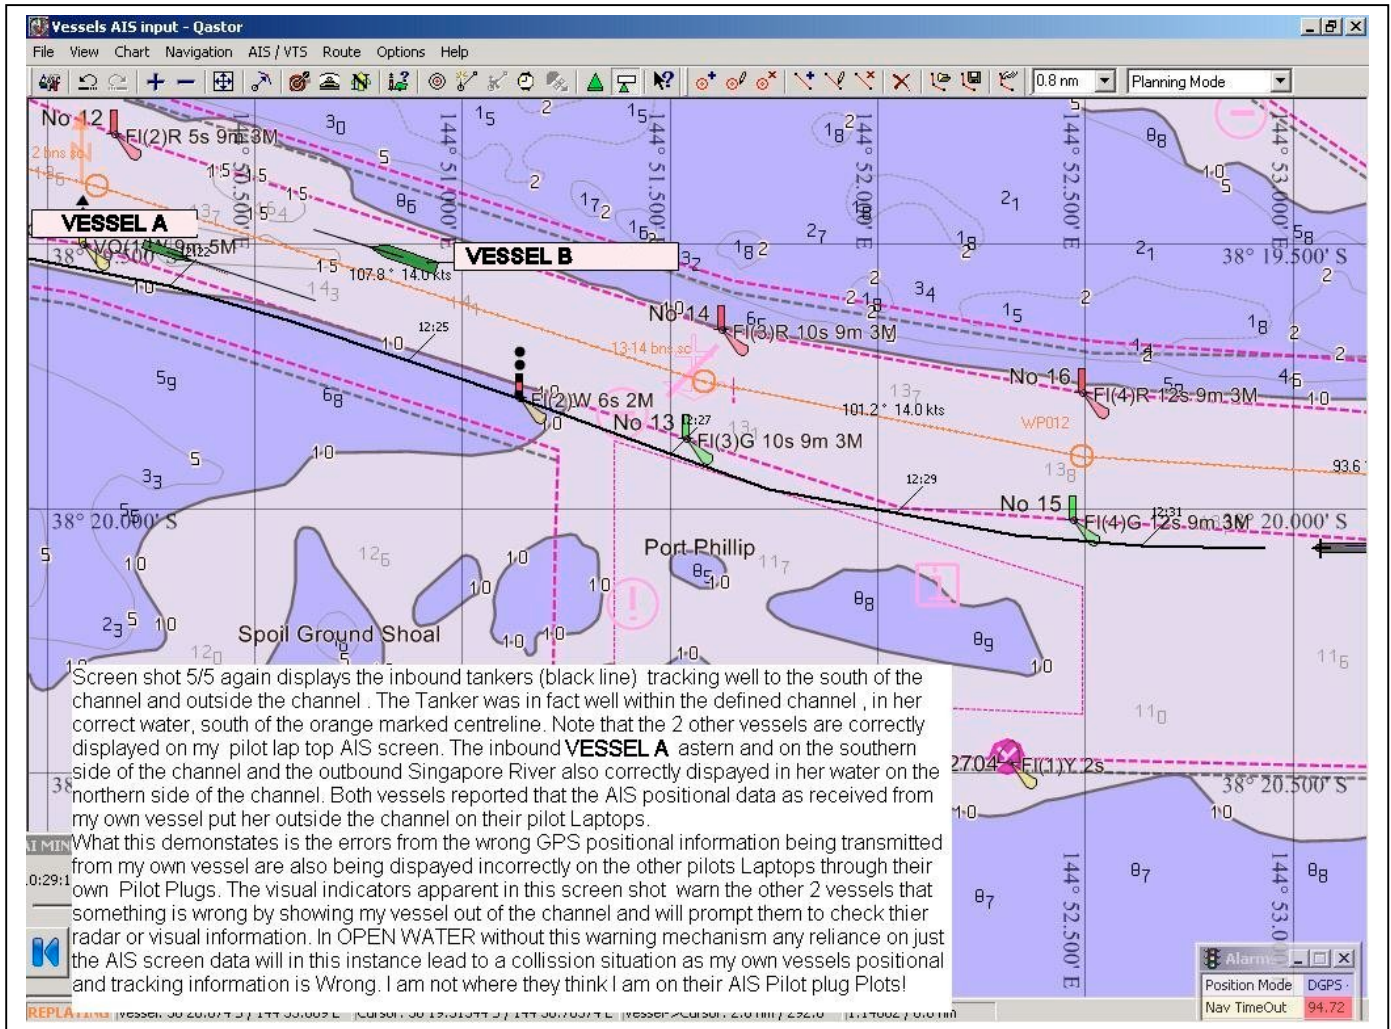
Image 5 – wrong datum being used in own vessel’s main GNSS receiver (shown on other displays).

The screenshot below shows the effect of the wrong chart datum being used in the vessel’s main GNSS receiver. The incorrect position is also being displayed on the other vessels’ Pilots’ Laptops. See Pilot’s comments on the screenshot itself.

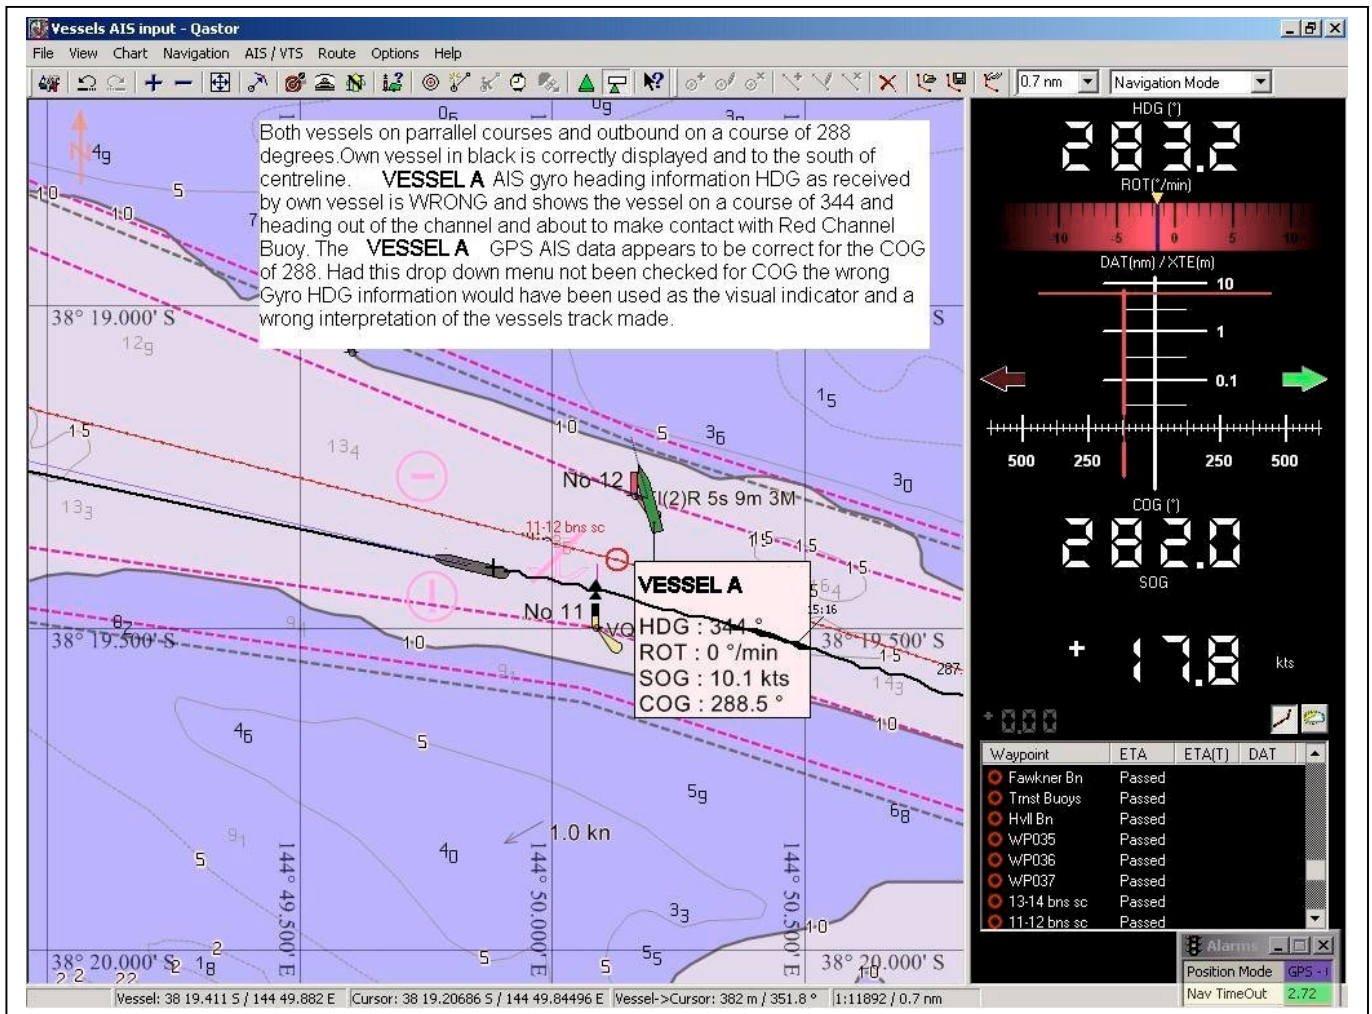
Image 6 – wrong true heading being transmitted by nearby vessel’s AIS transponder..

A The screenshot below shows the effect of the wrong heading true heading being transmitted by a nearby vessel’s transponder. See Pilot’s comments on the screenshot itself.

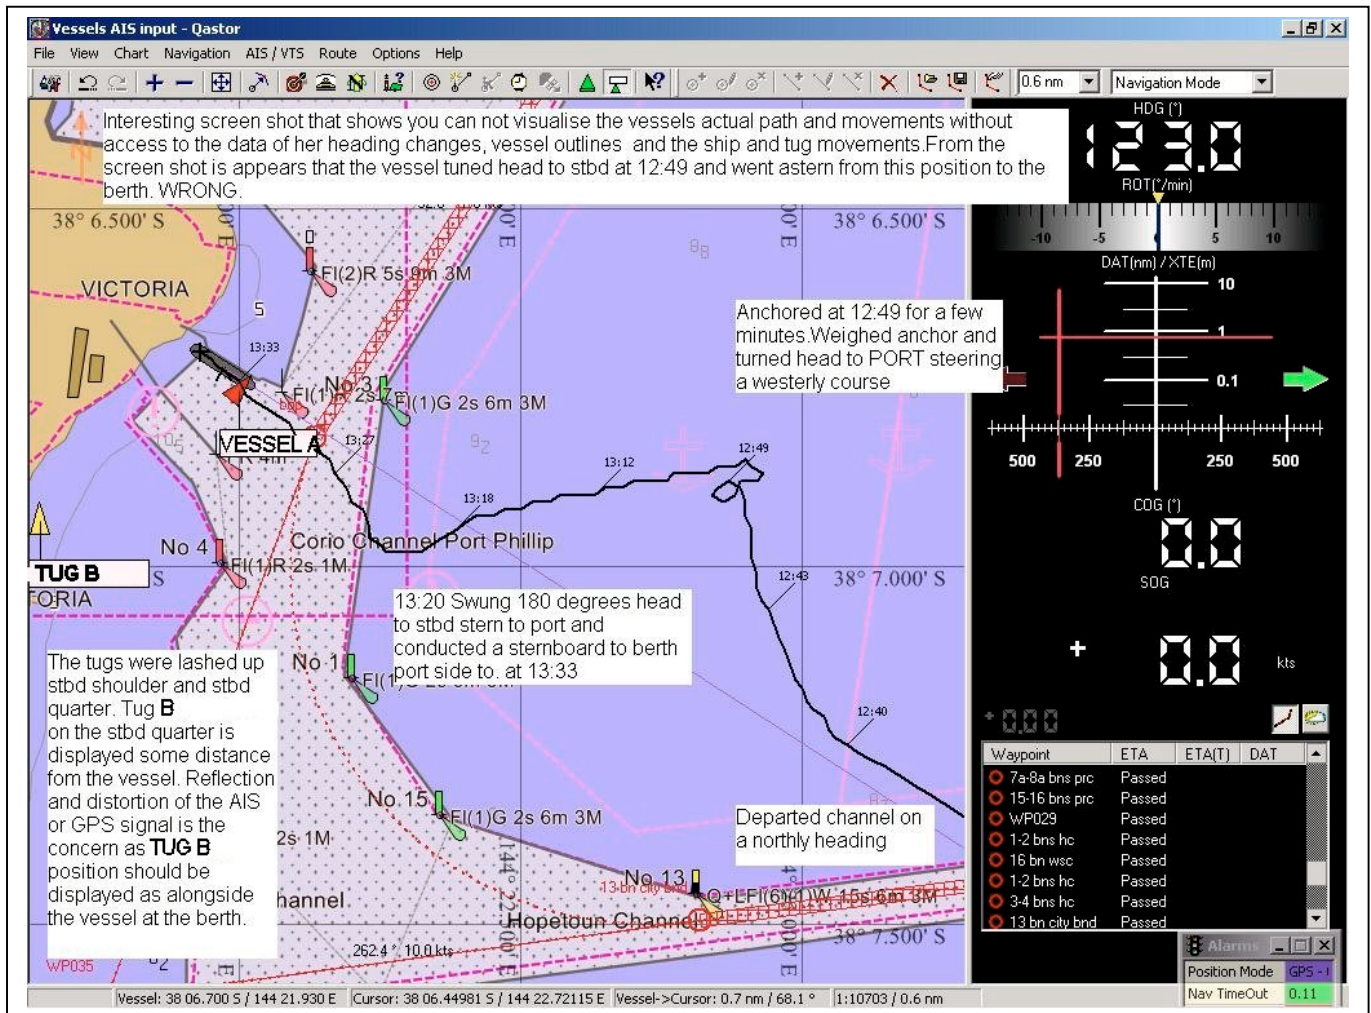
Image 7 – track replay and tug AIS positions display on Pilot Laptop.

A The screenshot below shows the effect of what was possibly a low logging interval set on the Pilot Laptop and also the effect of the Tug not receiving a good GNSS (GPS) fix. A newer GNSS receiver and/or improved positioning of antennas on the Tug might be able to improve this situation. See Pilot’s comments on the screenshot itself.

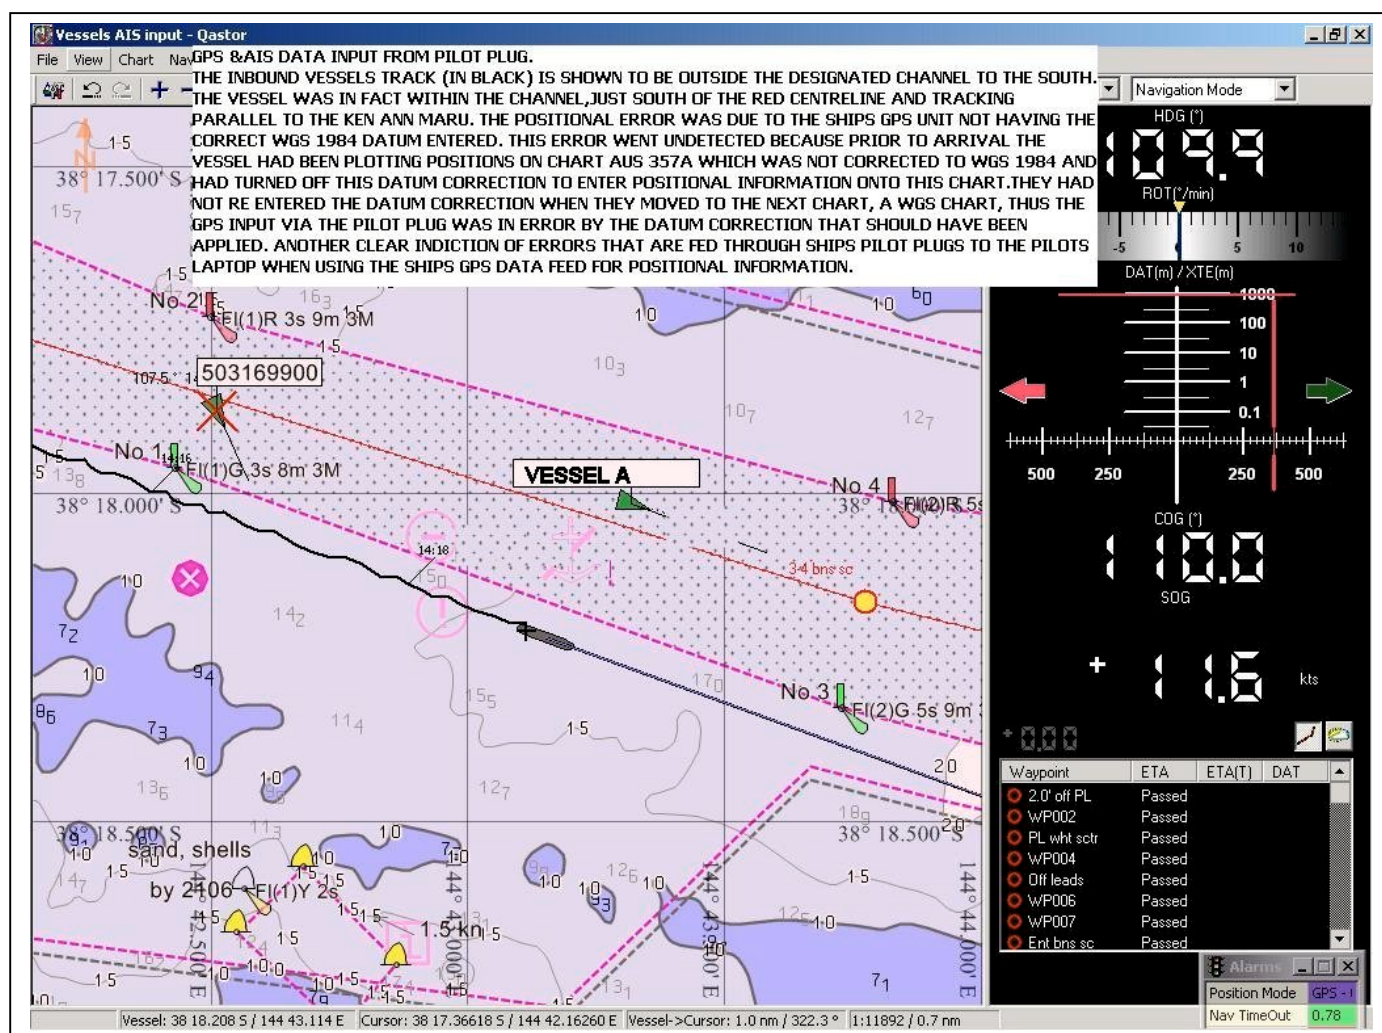
Image 8 – wrong datum being used in own vessel’s main GNSS receiver (shown on other displays).

The screenshot below shows the effect of the wrong chart datum being used in the vessel’s main GNSS receiver, later corrected. See Pilot’s comments on the screenshot itself.
