MARINE SAFETY INVESTIGATION

REPORT 173

Independent investigation into the lifeboat
accident and injury to crew aboard the
Panama flag bulk carrier

Cape Kestrel

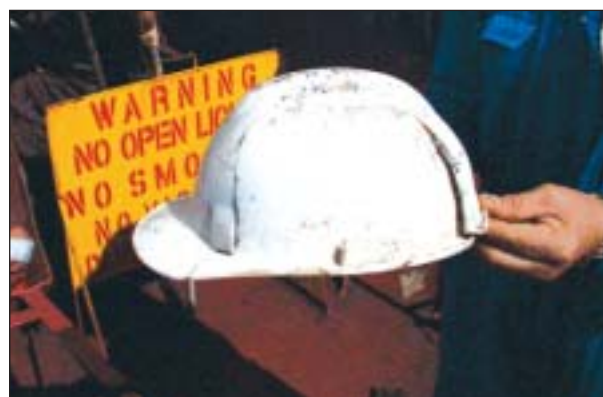
FIGURE 3:
Third mate's helmet after the accident

After the boat had fallen overboard, the chief engineer put the lifeboat ladder over the side as fast as he could and climbed down to the boat where he opened the side hatch and looked in. The mate was lying on his back in great pain, the second engineer was on the port side of the boat and the OS, on the starboard side, was complaining of severe pain in his chest. The bosun looked uninjured. The third mate, who had been operating the bilge pump, had blood on his forehead and over one eye. The helmet that he had been wearing had split but, in taking the impact of his contact with a part of the boat, it had probably saved his life.

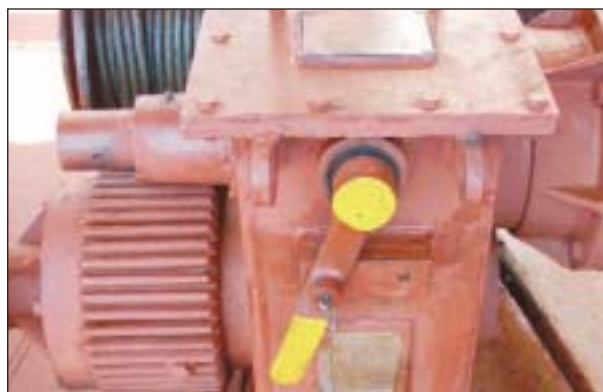
FIGURE 5:
Clutch lever for hoisting winch for port lifeboat

It is not clear if, on the day of the incident, the clutch lever was correctly positioned while the boat was being turned in. The master's opinion was that the boat came up too fast and that the cradles went through the limit switches, reaching the top with a bang that was audible on the bridge. It is probable that the clutch lever had not been moved to the correct position for turning the boat in.

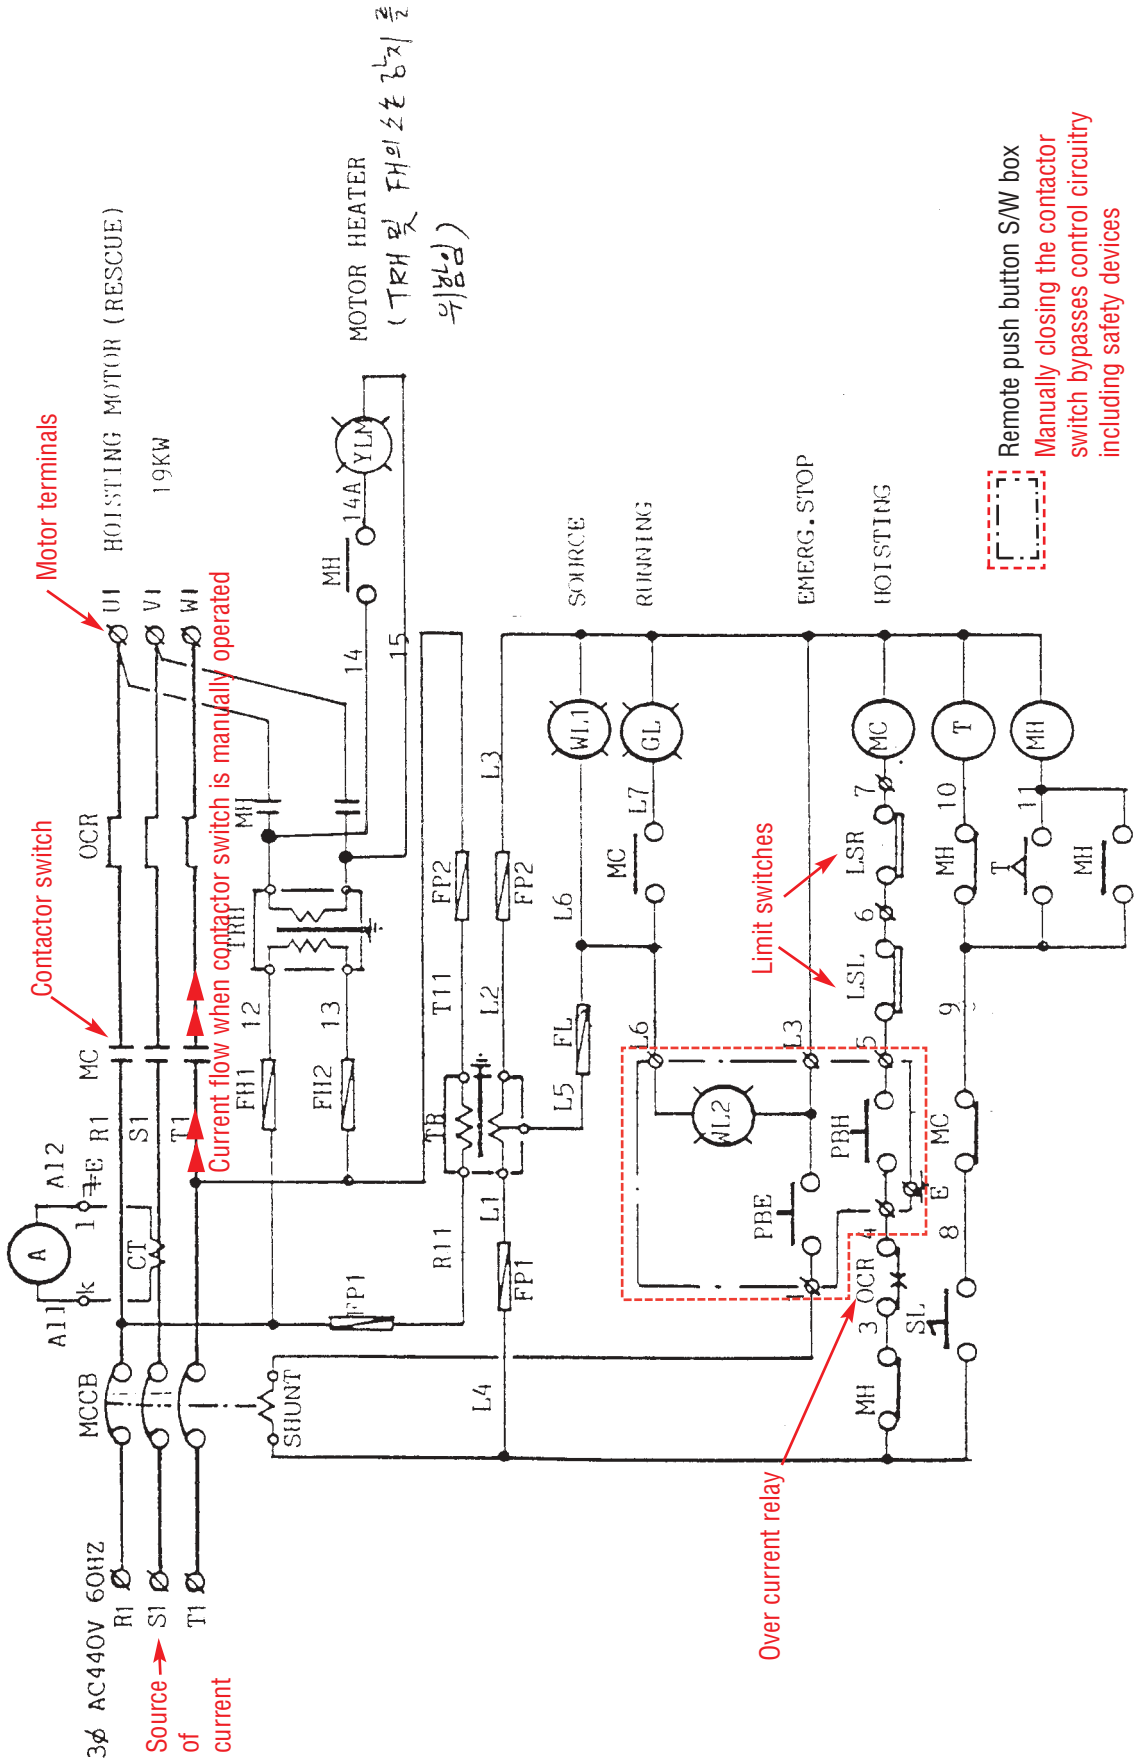
FIGURE 6:
Control circuit for rescue boat winch

The first engineer seemed unaware that operating the winch with the motor contactor meant that all the electrical safety interlocks, which were provided to prevent damage to the davits and the boats, had been bypassed. The chief engineer, who was aware of the manner in which the boat was being hoisted, should have warned the first engineer that hoisting of the boat should have been stopped before the limit switches were contacted.

As the ship carries no electrician, the engineers should have had sufficient electrical knowledge to be aware of the hazards associated with manual operation of the contactor to hoist the boat.

1. Warning notices should be posted at the starter box for all lifeboat winches drawing attention to the hazard of operating the winch with the contactor, particularly if there are personnel in the boat.

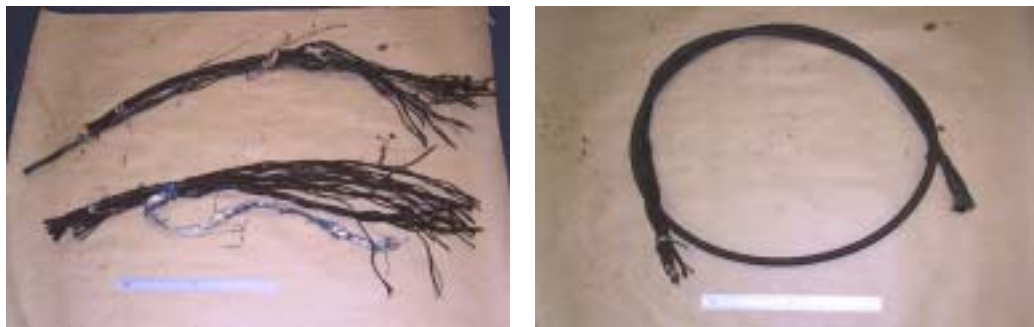
To determine the cause of the failure, the ATSB recovered and examined samples of the rope from both davits, including the fractured ends (figures 1 & 2). A copy of the original test certificate for the rope installed in the davits was also provided for reference (attachment A).

Figures 1 & 2. Davit wire rope samples as-received. Left are the samples from around the fracture; right is the two-metre length for mechanical testing.

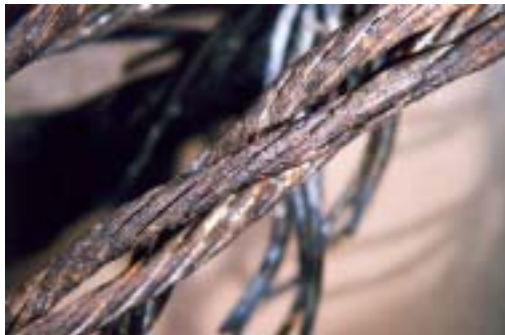
Examination after degreasing found the external rope strands around both fractures to be extensively corroded (figure 3). Appreciable proportions of the original cross-section had been lost on many of the individual wires, with the outer surfaces showing an uneven, pitted appearance. Between the wires, much of the galvanised zinc coating had also been lost to the effects of corrosion, producing large amounts of white corrosion product (figure 4). The strands from the internal windings generally showed more limited corrosion damage (figure 5). The extent and severity of the corrosion damage appeared to vary along the length of the ropes, with the most noticeably damaged regions being associated with the location of failure.

Figure 3 (top left). Illustrates the extent of the corrosion damage to the outer wire strands adjacent to the fracture.

The samples of rope examined showed extensive metal loss from corrosion; most notably on the outer strands from around the fracture location. The protective galvanised (zinc) coating had oxidised away completely in many areas, leaving the steel wires in the rope prone to corrosive attack. Marine environments are particularly aggressive in terms of corrosion damage, due in part to the high proportion of chloride compounds in seawater. The microanalysis conducted on the corroded wire surfaces confirmed the high level of chloride compounds present.

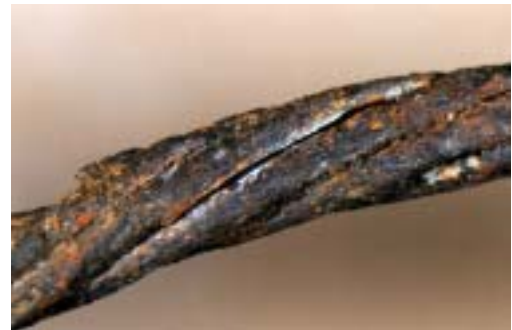
Figure 4 (above). Closer view of a single external wire strand – note the white zinc corrosion product between the wires.

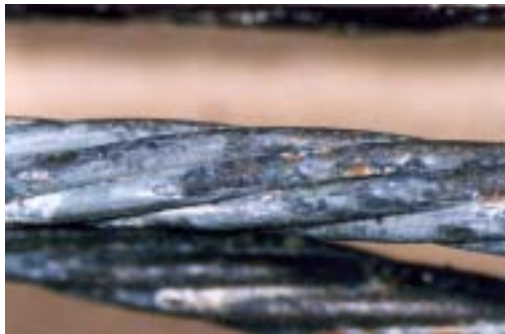
Figure 5 (left). Inner wire strand from the rope – notably less corrosion damage.

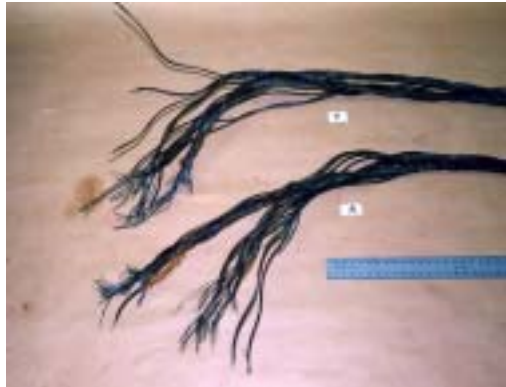
Figure 6 shows the fractured ends from the forward (F) and aft (A) davit wires. Both showed the unravelling of the outer strands for around 30 centimetres back from the point of failure, exposing the inner strands which typically splayed outward for only 5 centimetres (figure 7). Each of the eighteen fractured rope strands was examined individually at low magnification. In all cases, the wire elements showed evidence of localised plastic deformation or ‘necking’ of the material at the point of fracture. This was most evident on the core wire of each strand (figure 8), however the corroded outer wires also showed the effect (figure 9). Localised reduction of area (necking) at the point of fracture is a characteristic indication of tensile overload in ductile materials.

Figure 6. Forward and aft davit ropes at the point of failure. Note the splaying of the outer strands.

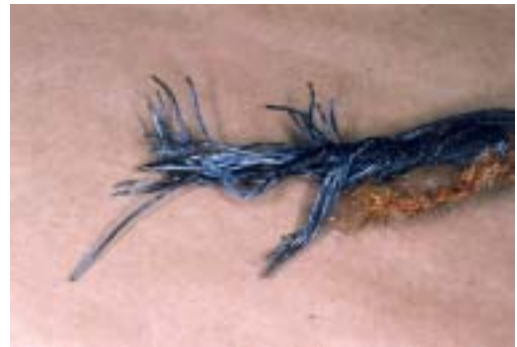
Figure 7. Inner wire strands at the point of failure.

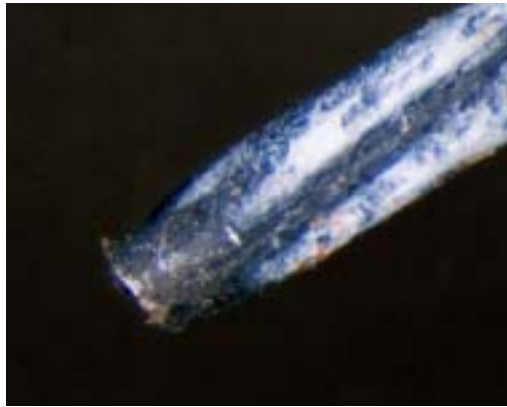
Figure 8. Ductile 'necking' of a strand core wire. Classic cup-cone style tensile fracture.

From the examinations conducted and reported herein, it was apparent that both the forward and aft lifeboat davit ropes had failed under tensile overloading conditions. The characteristic ‘necking’ or reduction in area visible on most wire elements was typical of this mechanism.

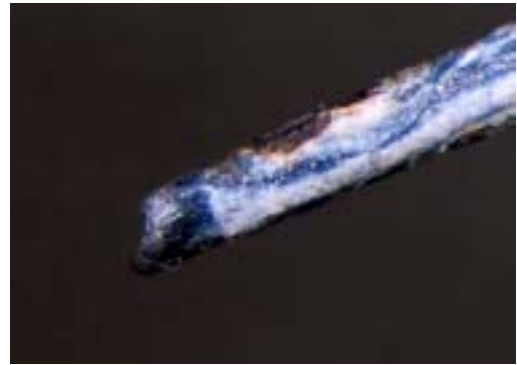
Figure 9. Strand outer wire also showing localised necking.

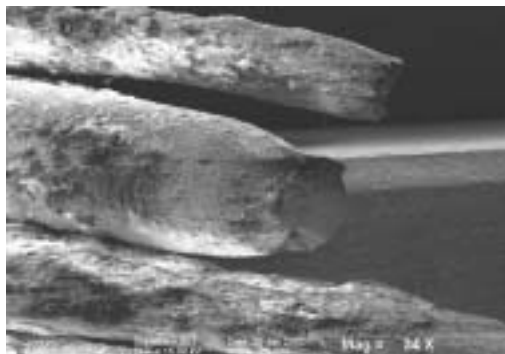
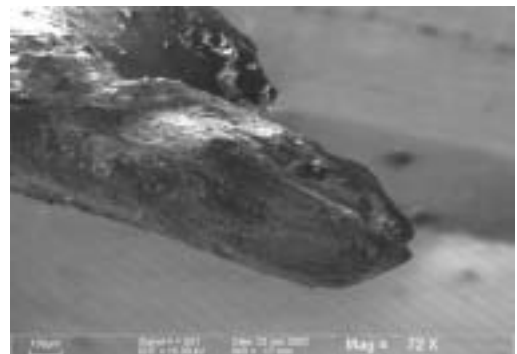
Samples of failed wires from both davit ropes were examined using the scanning electron microscope. This study confirmed the visual observations relating to the ductile tensile overload failure of the wires (figures 10 & 11).

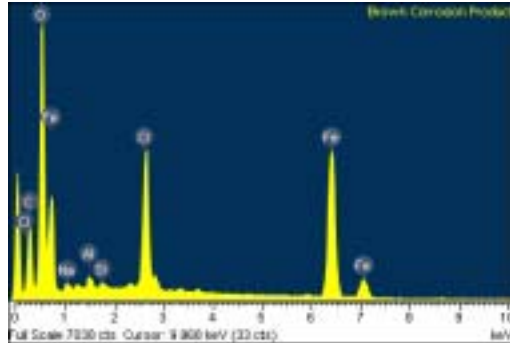
Analysis of the corrosion products present on the wire surfaces indicated the presence of significant levels of chloride and oxide compounds – both commonly associated with marine corrosion (figure 12).

Figure 12. Microanalysis spectra from a corroded wire surface. Note the large chloride and oxide peaks.
