Allision of Hong Kong-Registered Containership M/V *Cosco Busan*  
with the Delta Tower of the San Francisco–Oakland Bay Bridge  
San Francisco, California  
November 7, 2007

NTSB/MAR-09/01  
PB2009-916401

# **Marine Accident Report**

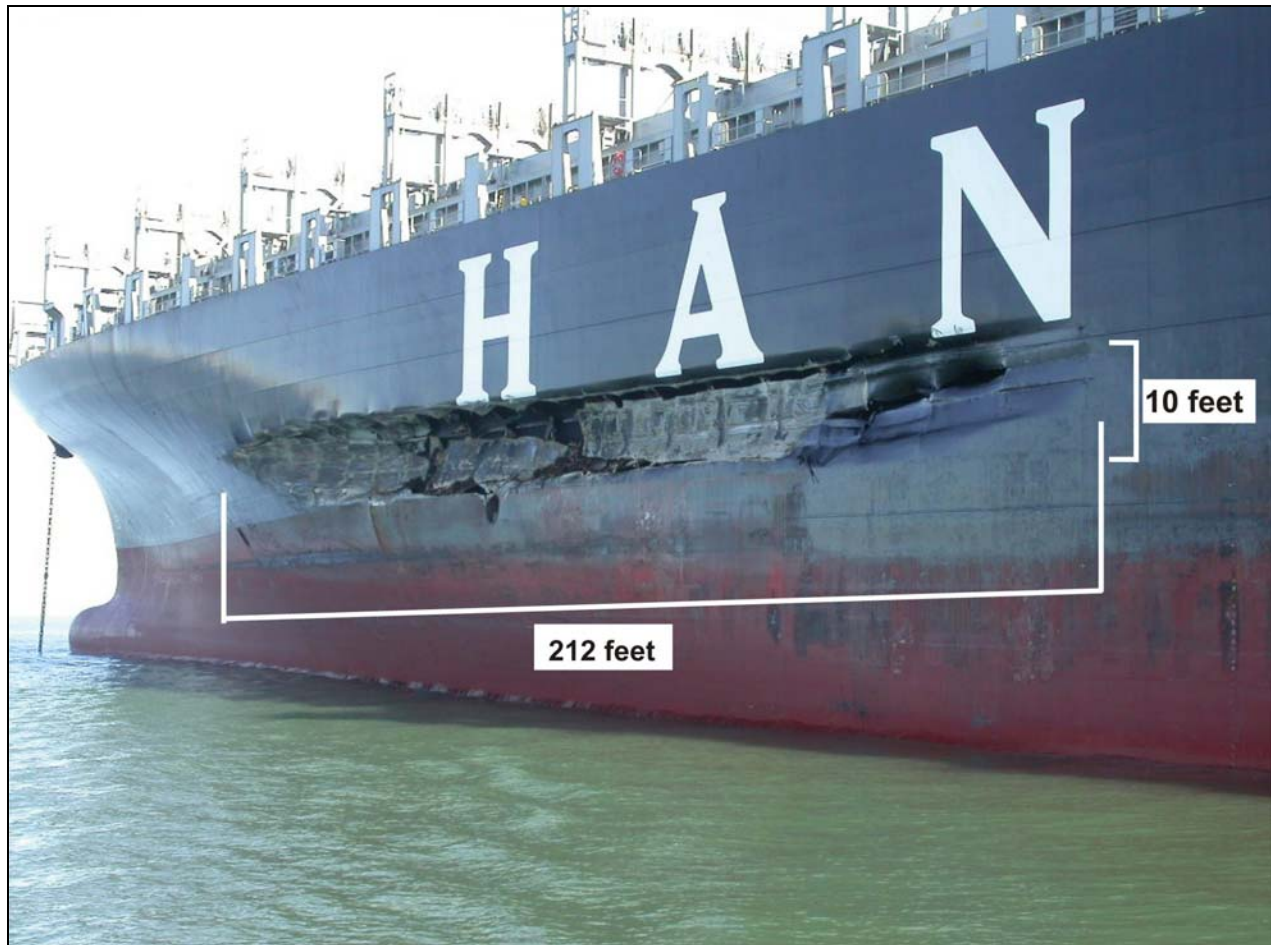
Damage to the *Cosco Busan* from its allision with the Bay Bridge was confined to the port side of the vessel, forward of the superstructure, above the waterline (figure 4) The Nos. 3 and 4 port fuel tanks were breached, as was the No. 2 port water ballast tank.

The *Cosco Busan*'s classification society, Germanischer Lloyd,<sup>36</sup> surveyed the vessel's damage on November 13, 2007. The forward-most point of the damage was about 237 feet aft of the ship's bow and extended along the port side of the vessel for about 212 feet. This damage area extended about 10 feet vertically up the hull side. The hull's shell plating<sup>37</sup> was torn open along the entire length of the damaged area. All the internal web frames in the damage area were deformed to some extent. Pipes, ladders, handrails, and gratings associated with all three of the damaged tanks were damaged or destroyed. Internal damage to the vessel did not extend past the inboard boundaries of the three breached tanks.

At the time of the allision, according to sounding tables from the day before the accident, the No. 3 port fuel tank was about 10 percent full. This placed the fuel level below the breach in the hull, and none of the fuel was released in the accident. Conversely, from the same day's soundings tables, the No. 4 port fuel tank was at 87 percent capacity, a level above that of the hull's postaccident portside damage.

**Figure 4.** Damage to the forward port side of the *Cosco Busan* after the allision with the bridge tower.

The *Cosco Busan* remained in the San Francisco Bay area for 30 days after the allision while temporary repairs were made to the vessel hull. The repairs consisted of fitting a plate over the shell opening. According to a Fleet Management official, the cost of the temporary repairs

totaled \$1,239,792. After completion of the temporary repairs, the vessel transited to China for permanent repairs. The damaged tanks were not used to carry fuel on that voyage. The vessel's temporary repairs were made to the outside shell plating, not the actual inner bunker fuel tank boundaries. The final repairs were completed in 13 days and cost an additional \$812,000. On January 11, 2008, the vessel was renamed *Hanjin Venezia*.

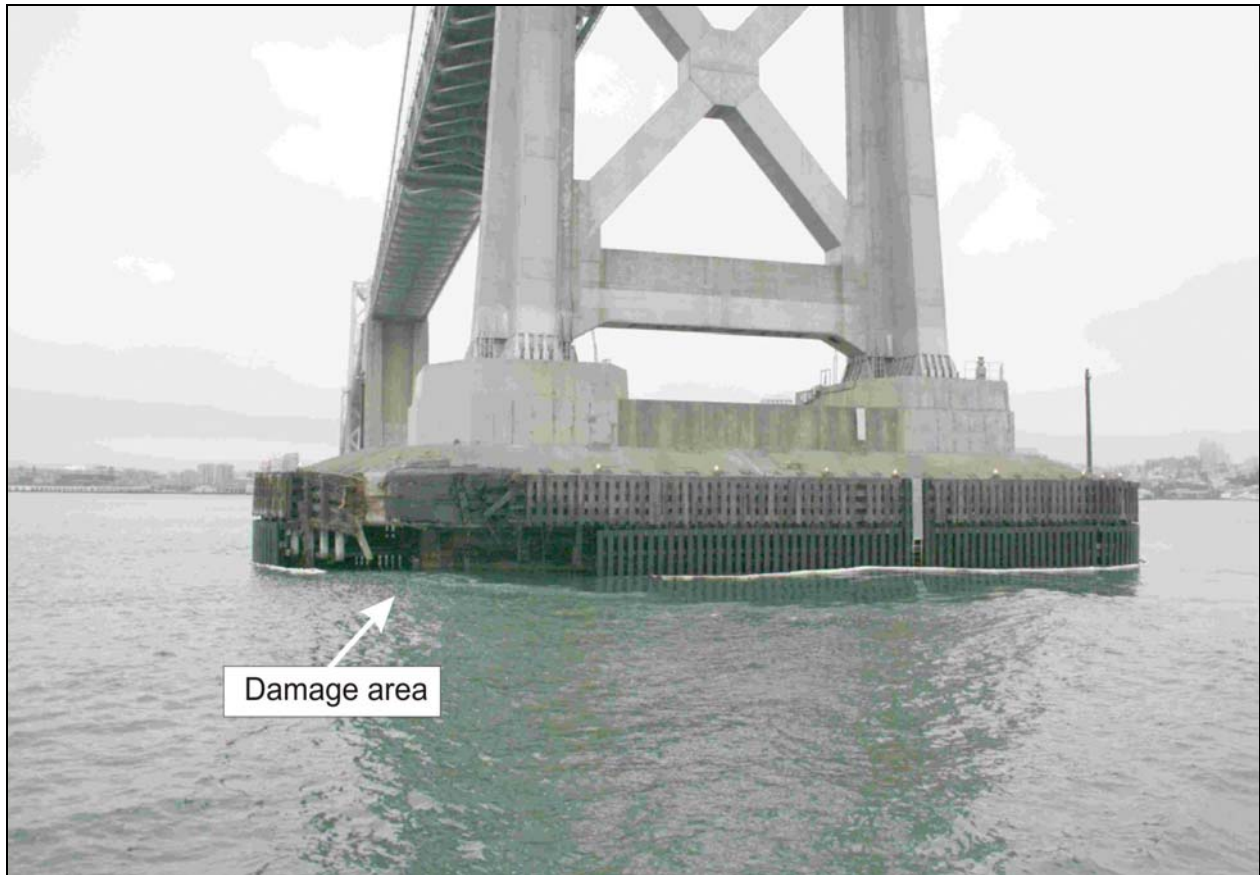
engineer, and a state transportation engineer inspected the pier. They found that about 100 feet of the fendering and skirt at the southeast corner of the Delta pier had been damaged (see figures 5 and 6), but they found no damage to the pier itself or to any other part of the bridge structure.

Cost to repair the damage was \$1.5 million. By 0950, Caltrans engineers had completed their inspection and found no damage that would compromise the structural integrity of the bridge.

**Figure 5.** Damaged fendering system at the base of the Bay Bridge Delta tower.

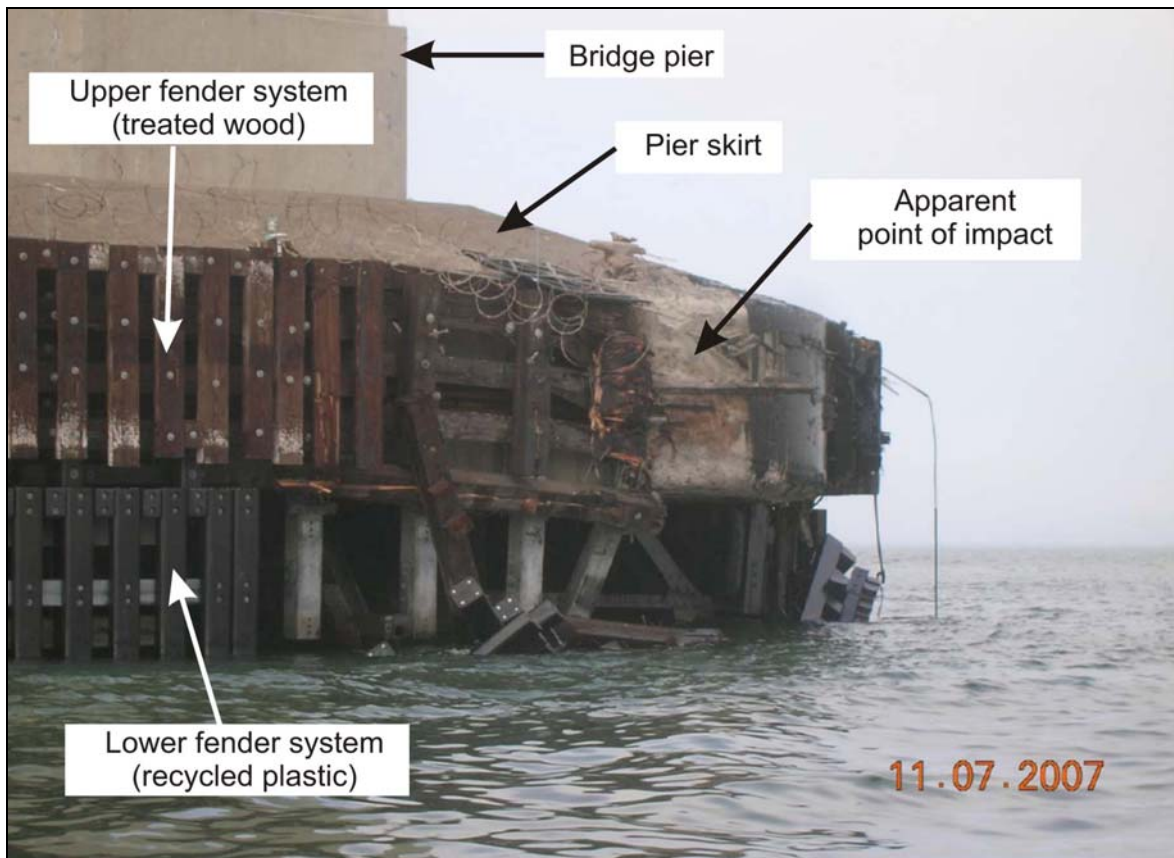
**Figure 6.** Close-up view of the fendering system at the base of the Delta tower showing the likely point of impact and a portion of the 100-foot-long damage area.

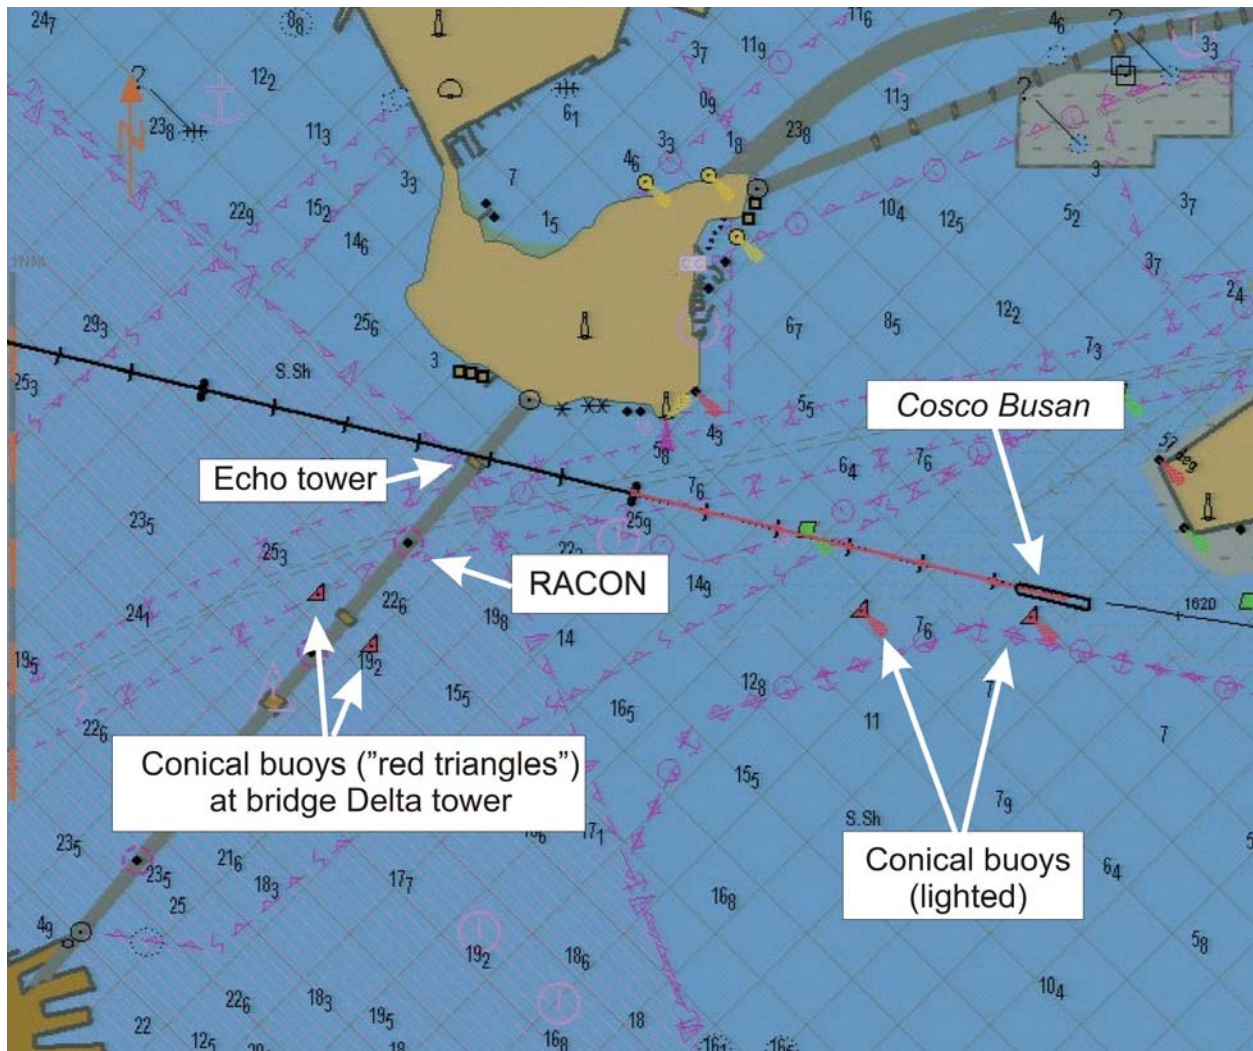
**Figure 8.** The Bay Bridge as displayed on the electronic chart on board the *Cosco Busan*. The chart display is from 0821:51, the approximate time the pilot questioned the ship's master about the meaning of the red triangles at the bridge.

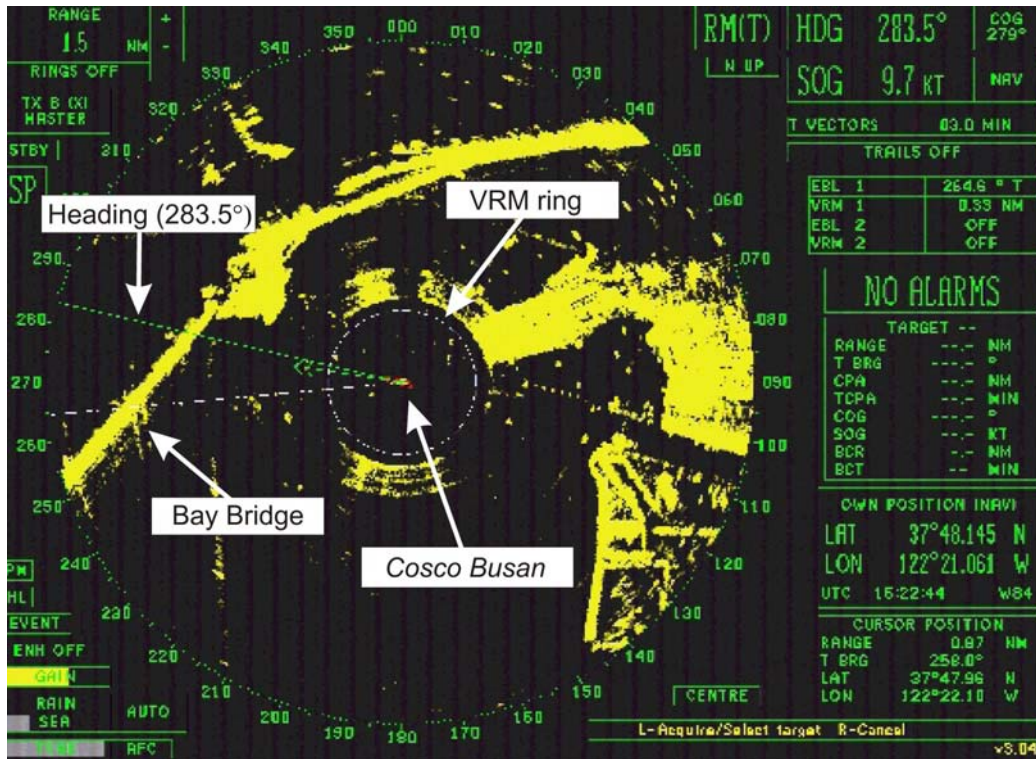
The *Cosco Busan* pilot told investigators that about the time the vessel began its initial turn to port (about 0823), “the radar picture of the bridge got distorted. It got wider. The bridge got wider. The RACON never appeared.” Investigators reviewed the radar images captured by the VDR and assessed the quality and consistency of the images that were displayed during the accident voyage (figure 13). This review revealed that the radar returns from the Bay Bridge did not change significantly from the time the bridge first became visible on the display about 0819 until about 0826 when the upper end of the bridge appeared to widen. The upper portion of the bridge appeared to widen on the radar image for about 1 minute before beginning to return to normal.

During the public hearing on this accident, the Sperry manager of product support and training reviewed the image and attributed the change in the bridge’s appearance to the *Cosco Busan* being almost abeam of the bridge at that point, with the top section of the bridge providing a much stronger radar return because the radar was “shooting . . . [radiofrequency] energy directly into the girders . . .” Figure 14 shows the radar image that was being displayed on the *Cosco Busan* at the time the radar image of the Bay Bridge became, in the words of the pilot, “distorted.” After about 2 minutes, the entire bridge began to appear thinner on the radar screen as the ship approached the bridge and more of its radar waves passed beneath the bridge instead of being reflected back. The signature of the RACON transponder at the midpoint of the Delta–Echo span also appeared on the radar screen at regular intervals throughout the voyage.

**Figure 13.** (Top) Radar image displayed on the bridge of the *Cosco Busan* at 0822:44, just before the vessel turned to port, and (bottom) the radar image at 0826:14, just after the vessel made the turn to port. In the bottom image, note the identifier for the RACON at the center of the Delta–Echo span of the bridge.

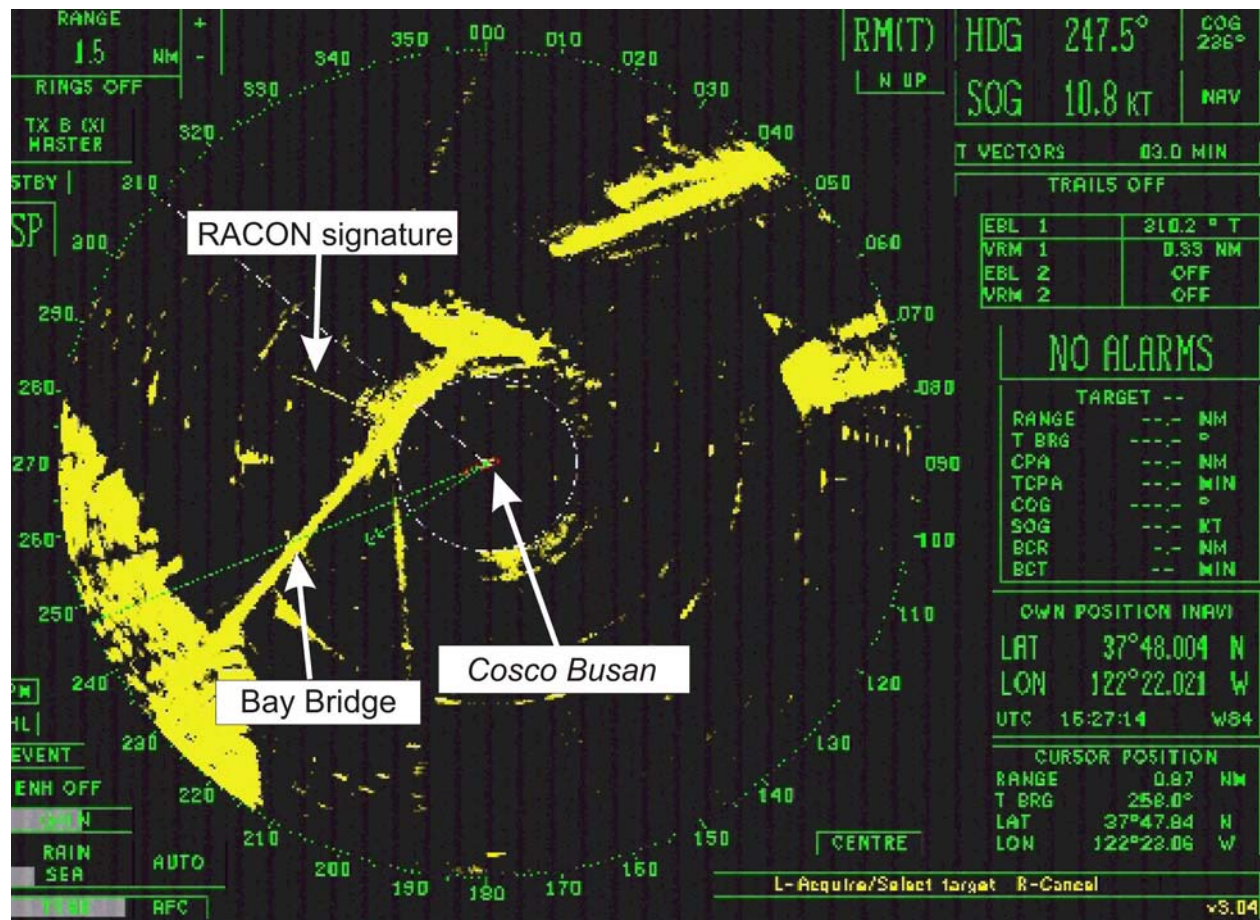
**Figure 14.** Radar image on board the *Cosco Busan* at 0827:14. According to investigators, 0827:14 was the time at which the upper portion of the bridge appeared the most enlarged on the radar image before returning to normal.
