Marine Investigation Report
Accidental Release of Lifeboat
Bulk Carrier *Pacmonarch*
English Bay, Vancouver, British Columbia
26 October 2000

Report Number M00W0265

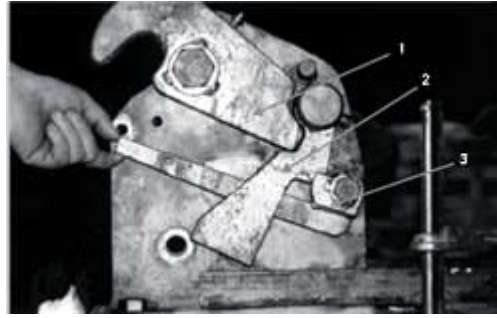
Photo 10. View of hook in load-bearing (reset) condition
1. Hook, 2. Blocking lever,
3. Reset lever

In the load-bearing or reset condition of the hook assembly (see [Photograph 10](#)), the flat end of the hook bears against and transmits a load onto the blocking lever, which in turn rests against a cam profile on the reset lever. At its contact surface with the hook, the blocking lever has a relief angle of 18° . As long as the reset lever remains in a position where its cam prevents the blocking lever from rotating downward, the hook remains locked and can carry its portion of the designed weight of the lifeboat and its contents (see [Photograph 10](#)).

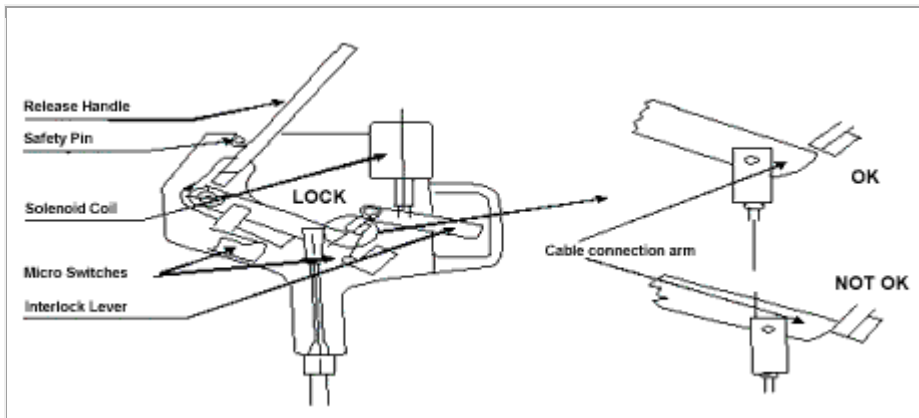
Figure 4. Internal schematic of central release control assembly

The lamps' indications are dictated by the contacts made between the cable connection arms, the interlock lever, and their respective microswitches. The positioning of these microswitches ([see Figure 4](#)), and the excessive play found in their sensing arms, allowed the panel lamps to falsely indicate the position of the interlock lever. When one or both of the cable connection arms were not being blocked by the interlock lever, the panel lights could incorrectly indicate that they were blocked.

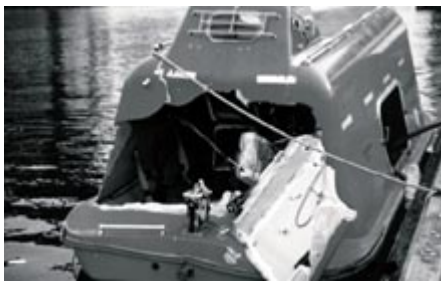
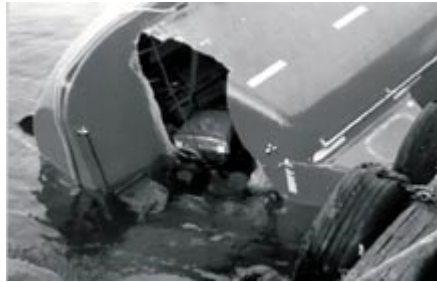
Photo 14. Damage to the stern of the lifeboat

Photo 15. Damage to the stern of the lifeboat

The impact with the water caused considerable damage to the stern of the lifeboat, with most of the damage concentrated around the canopy. The vertical panel was pushed inward, and the glass-reinforced plastic was torn right through. During rescue operations, divers further cut this torn opening and folded back the entire vertical panel, giving them unhindered access to the inside of the lifeboat (see [Photograph 14, 15](#)).

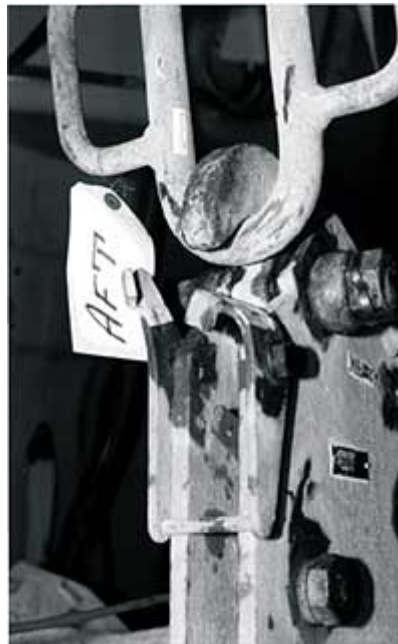
Photo 16. Damage to the after retaining latch

The retaining latch on the after hook assembly was damaged in such a way that its two vertical forked arms were both bent sideways and outboard of the lifeboat (see [Photograph 16](#)). The after hook was not damaged, but had scoring marks on its inside surface in the area that comes in contact with the suspension ring. The after suspension ring was not damaged but did have two small scoring marks on the outside bottom surface in an area that comes in line with the forked arms of the retaining latch (see [Photograph 17](#)).

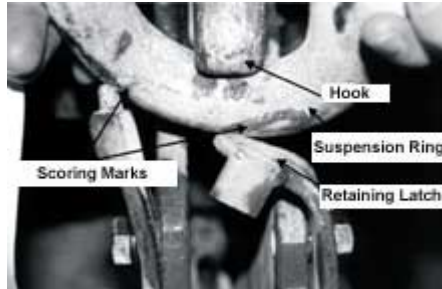
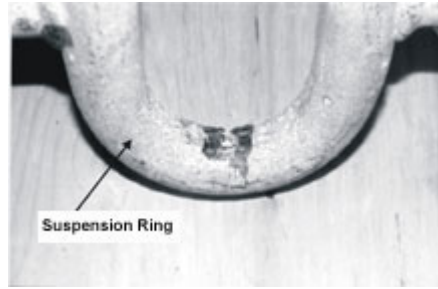
Photo 17. Scoring marks on the suspension ring

Photo 18. Scoring marks on the suspension ring

The lifeboat at this point was bow down around 40° (as suggested by matching the witness marks on the damage to the after hook and its suspension ring) when the gripe freed itself and detached from the after bollard. At this angle, the after suspension ring bore against the tip of the hook, and the retaining latch overcame the resistance offered by it and slipped out. Completely separated from the after falls, the lifeboat swung like a pendulum about the forward hook, which was still attached to the forward falls.

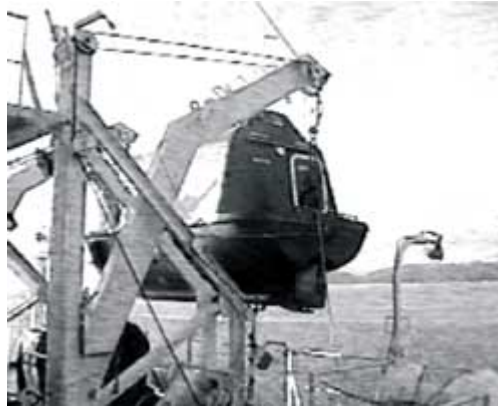
During the initial part of the launch sequence, the davit's luffing action toward the ship's side causes the lifeboat to swing outward. As the davit draws away from its support frame, it creates an ever increasing gap between itself and the rigid frame. This gap frees the rotating lever, to which the davit end of the gripe is hooked, and allows the lever to turn and release the gripe.

Photo 19. Still from video showing gripe wrapped around after bollard

The lifeboat's outward motion creates tension in the gripes, which in turn creates angular velocity in the free end of the gripe. The free end of the gripe falls, causing the gripe to loop around the bollard and, as the relative distance between the free end of the gripe and the bollard reduces, the angular velocity of the free end increases.

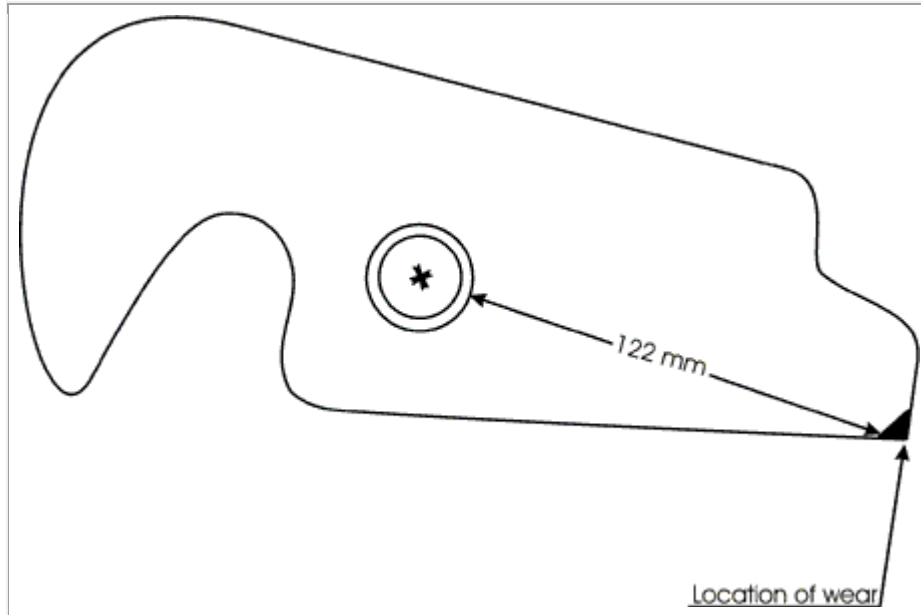
found to be within specification at 122.6 mm. However, on the after hook it was found to be 121.8 mm on average ([see Figure 7](#)). The retaining latch is designed to pivot such that it can only open into the hook ([see Figure 6](#)). This design feature allows the suspension ring to be inserted into the hook assembly and prevents the ring from inadvertently slipping out. The retaining latch is not designed to carry any significant amount of weight.

Figure 7. The release hook, the frame, and the lever should be replaced when the wear at the contact point between the release hook and the frame reaches 122 mm for a 2.5-ton hook.

Although this length on the after hook was found to be around 121.8 mm (0.2 mm below specification), the design had an adequate factor of safety, and there is no indication that this hook ever slipped past its blocking lever. However, the lifeboat and its hook assemblies were only about a year old, and the lifeboat itself had only been launched about four or five times. This use is not considered sufficient to have caused appreciable wear.

Minimal wear was found on this surface and the original radius was intact. The manufactured length from the end of the hook's load-transmitting surface to the circumference of its pivot was therefore 121.8 mm. Because the equipment was new and the wear minimal, this length is a deviation from the designed profile and indicates a manufacturing nonconformity.

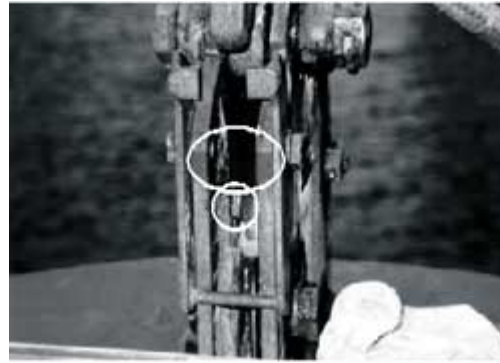
When the hook is fully and properly reset, the red mark on the tip of the reset lever should line up with the corresponding red mark on the cheek plates of the hook assembly. This alignment provides visual feedback to the operator that the lever is in the correct position and confirms that the hook has been fully reset.

Photo 20. Alignment marks between the cheek plates and the reset lever

If the hook reset indicators are not aligned, the possibility of error exists, since the task now changes from one where a precise judgement is required (whether the red reference marks are aligned) to one where an imprecise judgement is required (whether the reference marks are "close enough"). Less precise specifications result in more subjective judgements and a greater risk of error.
