Report of safety investigation

Stranding of the chemical tanker vessel SICHEM OSPREY on 10 February 2010 on Clipperton Island

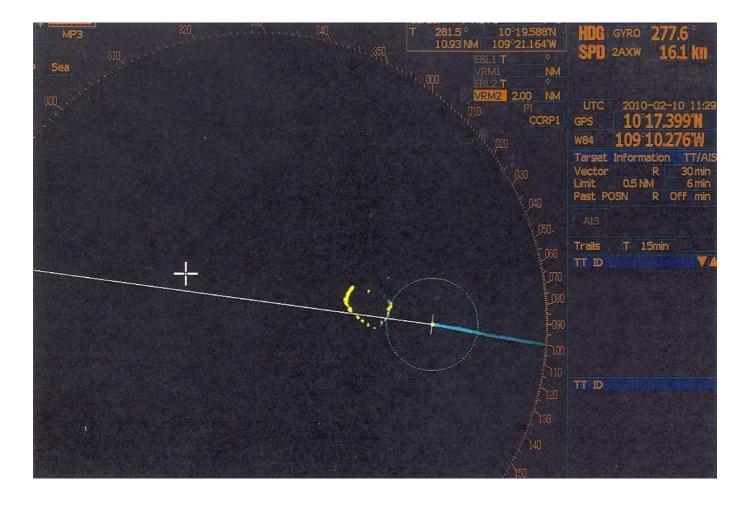
At **4.29 am**, the radar display variable range marker (2 nautical miles) was tangential to the edge of the island.

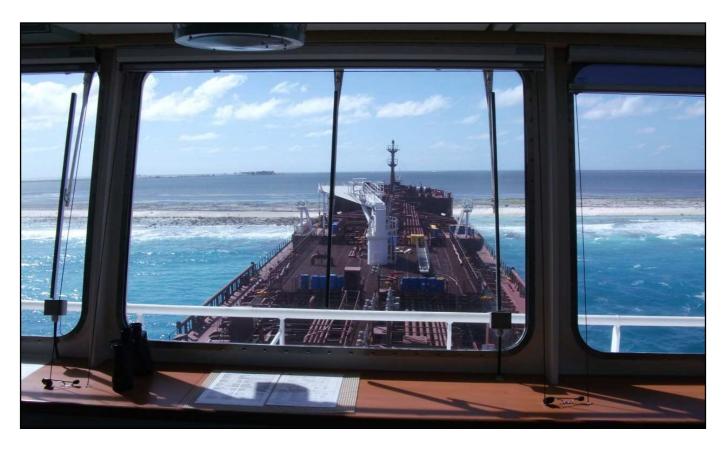
View from the bridge of the ship aground
