Accident
Investigation Board
Norway

REPORT

Marine 2020/02

REPORT ON OCCUPATIONAL ACCIDENT ON BOARD THE FACTORY TRAWLER NORDSTAR ON 10 JUNE 2018

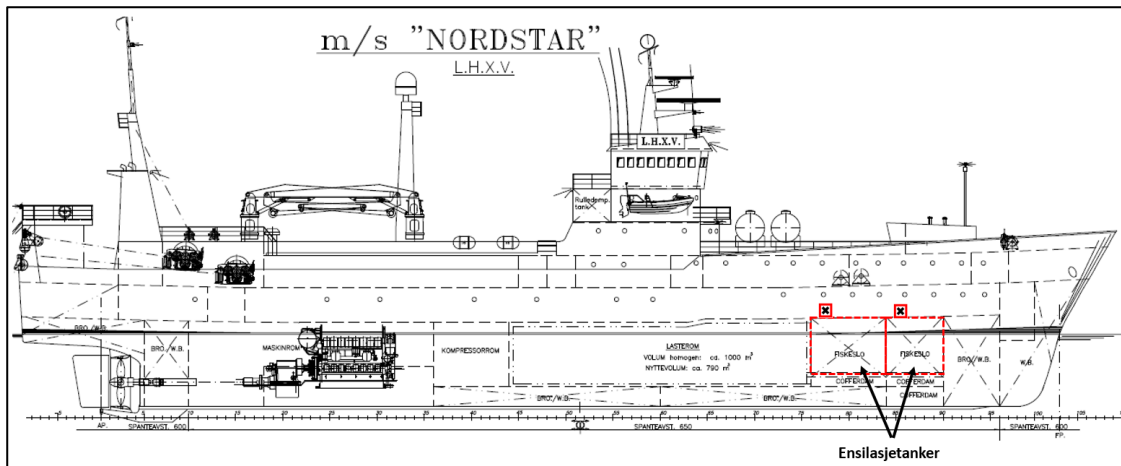
The hatches to the two forward silage tanks were located inside on the main deck (see Figure 3), forward of the factory. The tanks had not been cleaned since the last voyage on 3 May 2018, and there was still silage residue at the bottom of the tanks. Normally, the tanks would have been cleaned when they were fishing for redfish, but during this voyage, the tanks had been filled with water and used as ballast tanks.

Figure 3: The vessel's four silage tanks were located in the foreship, indicated by red dotted lines. The access hatches were located on the factory deck, indicated by a red square with a black x. Source: GH Marine/AIBN

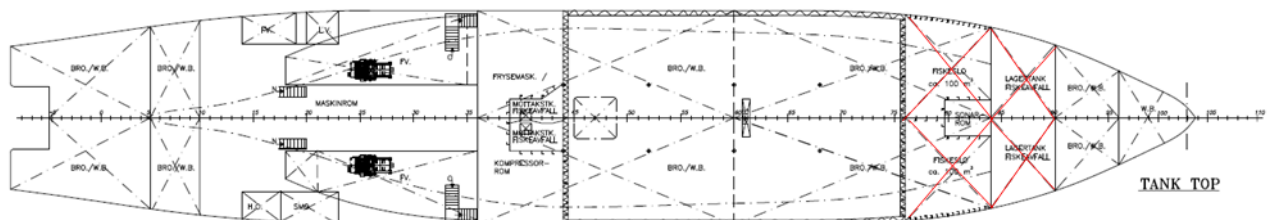
The production plant in itself does not affect the classification requirements, but four storage tanks for silage have been built, see Figure 7. In connection with the building of these tanks, a new inclining test was conducted and new stability calculations, a new tank plan and general arrangement (GA) were drawn up.

Figure 7: GA drawing showing the four storage tanks (indicated by red crosses) for silage. Source: Nordnes
