# The lifeboat imbroglio

## Captain Paul Drouin MNI

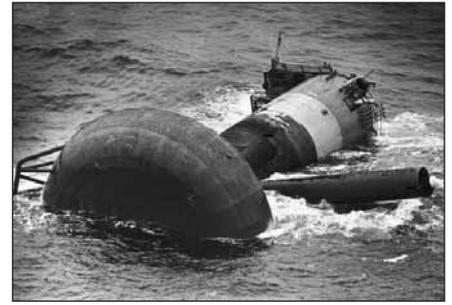
'On board *Alexander L Kielland* there were seven covered lifeboats, each with seats for 50 men. Four of the lifeboats were lowered without particular problems. On the other hand, problems occurred with the release of the lifeboat hooks. The hooks which were equipped with simultaneous release cannot be released as long as they are under load and this was difficult due to the rough sea on the day of the accident. For this reason three of the boats were blown against the platform and crashed. On the fourth boat the after part of the wheelhouse was crushed. Through the opening caused by the crash a man managed to release the after hook by hand. Before that someone had succeeded in one way or another to release the forward hook. A fifth boat came

down on the water bottom-up when the platform capsized. The hooks had been released in some way or another.'

▲ Figure 1: *Alexander L Kelland*  
© Scanpix/Aftenposten
