Report of safety investigation

LIFEBOAT ACCIDENT

CMA CGM

ON 15 APRIL 2011

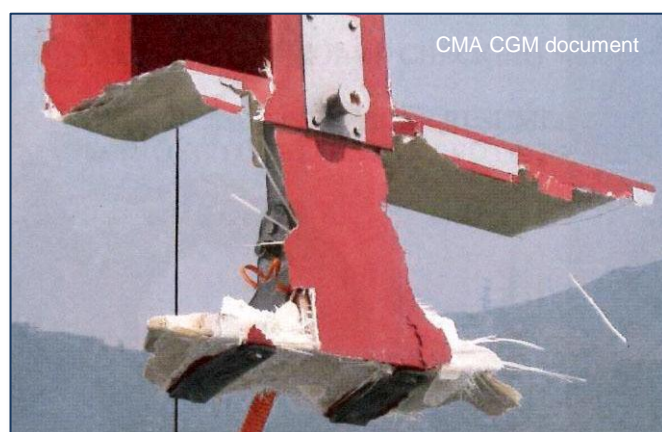
In these conditions, with her structure too weak to hold her own weight and her crew's, even with only few people aboard, on only one hook, the boat (although built according to the current regulation) do not act as a protection cell at all, as long as she is not floating normally.

The weakness of the structure is an **aggravating factor** of the consequences of the accident. The break and the consequent fall have deprived the crew of a chance for survival.

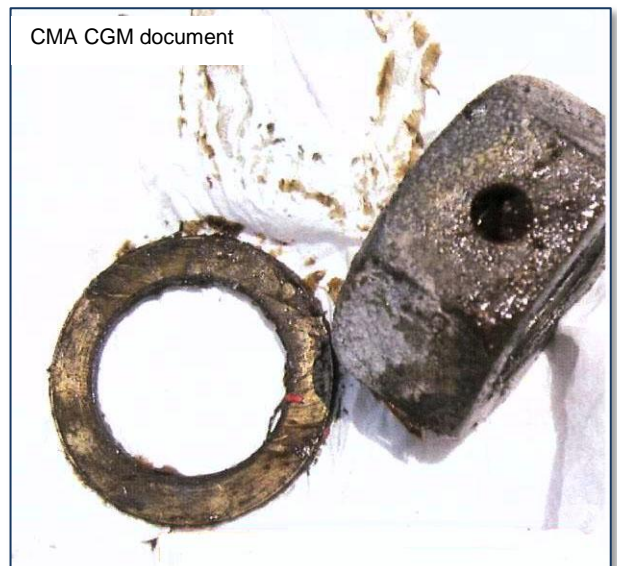
As it has been noticed above, the access to the fore pulley block of the lifeboat is uneasy and non-secure. Nevertheless, the tick box "good" of item n° 4 "sheave" in the starboard davit check-list had been ticked during the comprehensive survey carried out in September 2010.

It is likely that the fault (missing pin and/or nut partially unscrewed) should have been detected through a close visual survey of the swivel. Lastly, if there was a physical impossibility to achieve this survey, the tick box "good" should not have been ticked.

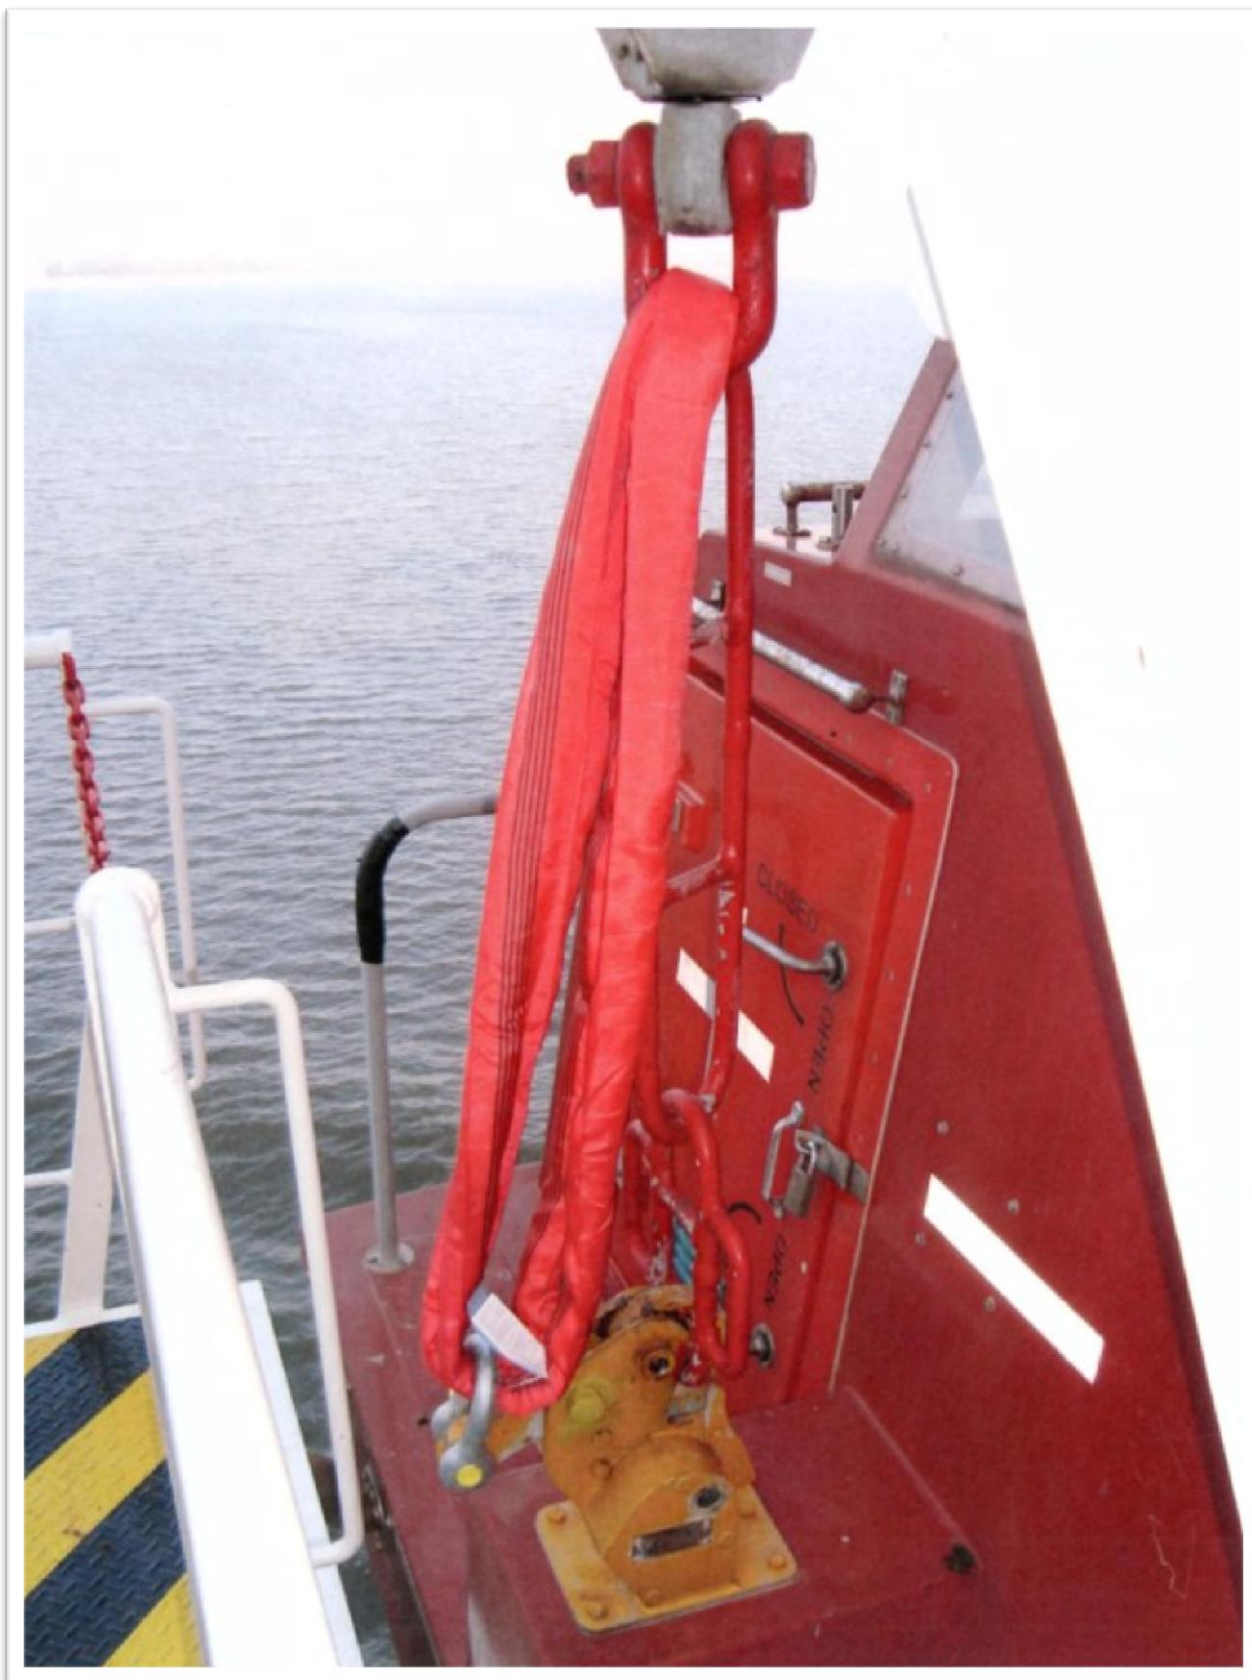
Since February 2011 the sling had been replaced with a nylon belt (Fall Prevention Device as recommended by the IMO, and resistant to six times the usual load – see picture Appendix B).

Ceinture de liaison entre émerillon et croc de largage
(Fall Protection Device)
