Allision of Hong Kong-Registered Containership M/V *Cosco Busan*  
with the Delta Tower of the San Francisco–Oakland Bay Bridge  
San Francisco, California  
November 7, 2007

NTSB/MAR-09/01  
PB2009-916401

# **Marine Accident Report**

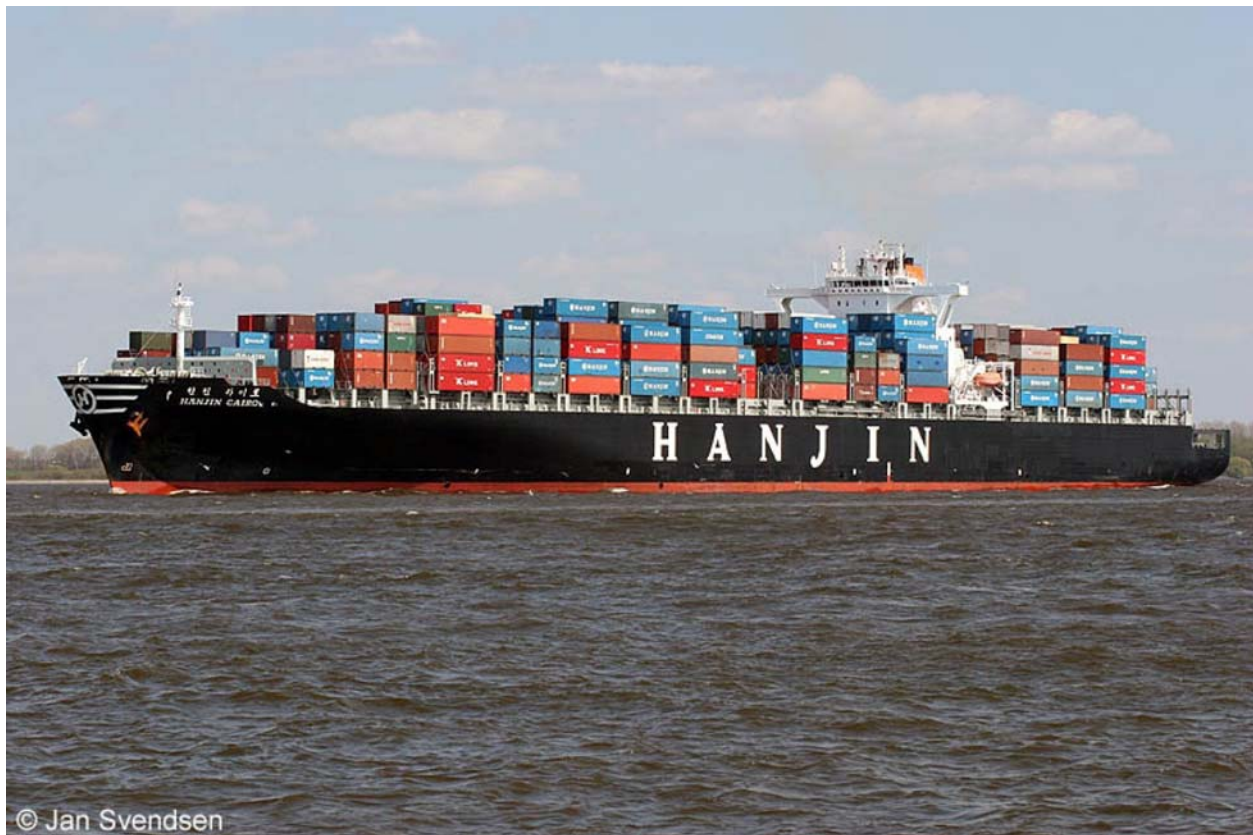
**Figure 1.** The *Hanjin Cairo*, which would later (in November 2006) be renamed *Cosco Busan*.

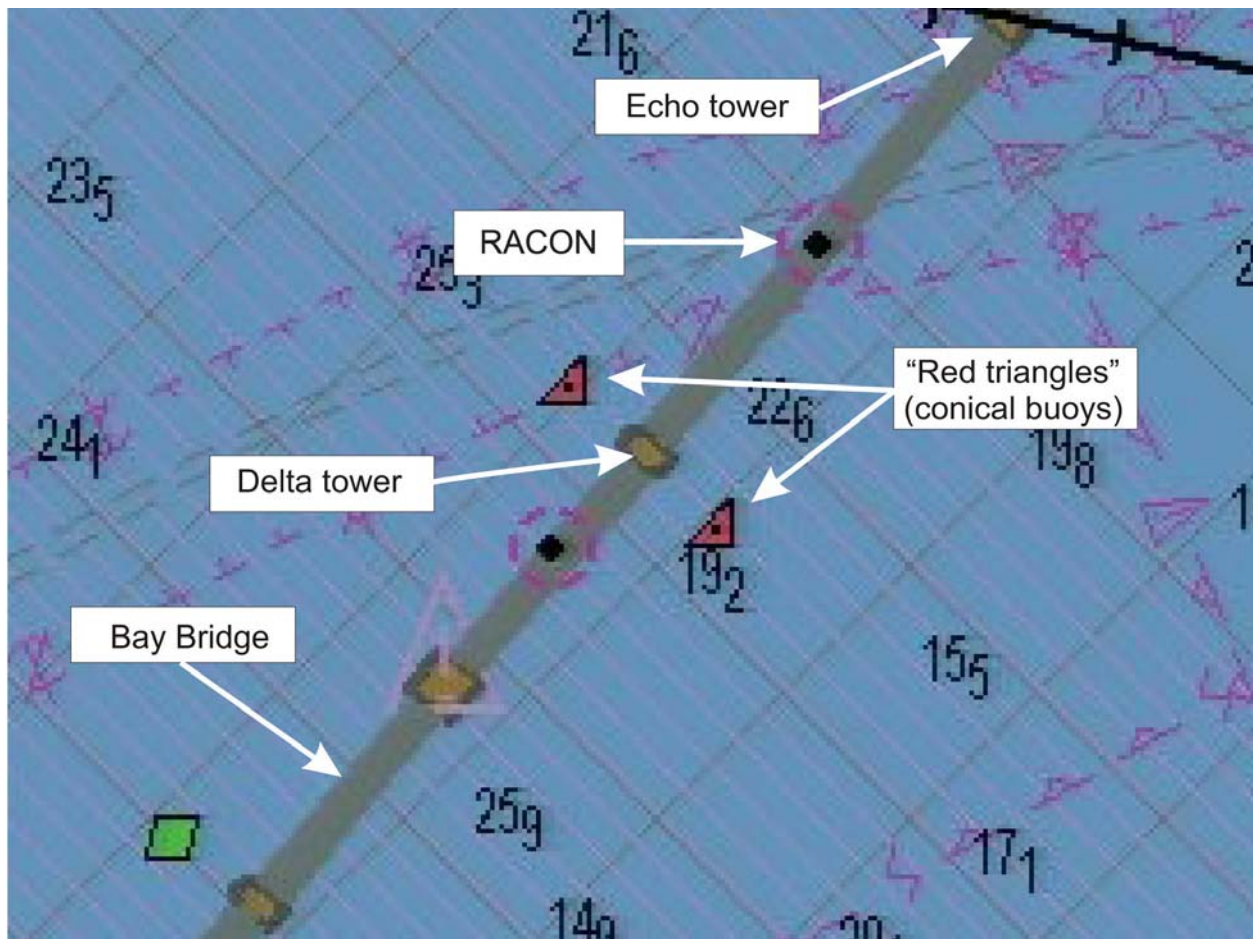
**Figure 2.** An enlarged section of the electronic chart on board the *Cosco Busan*. Two conical buoys, positioned on either side of the Delta tower, are displayed as red triangles on the electronic chart.

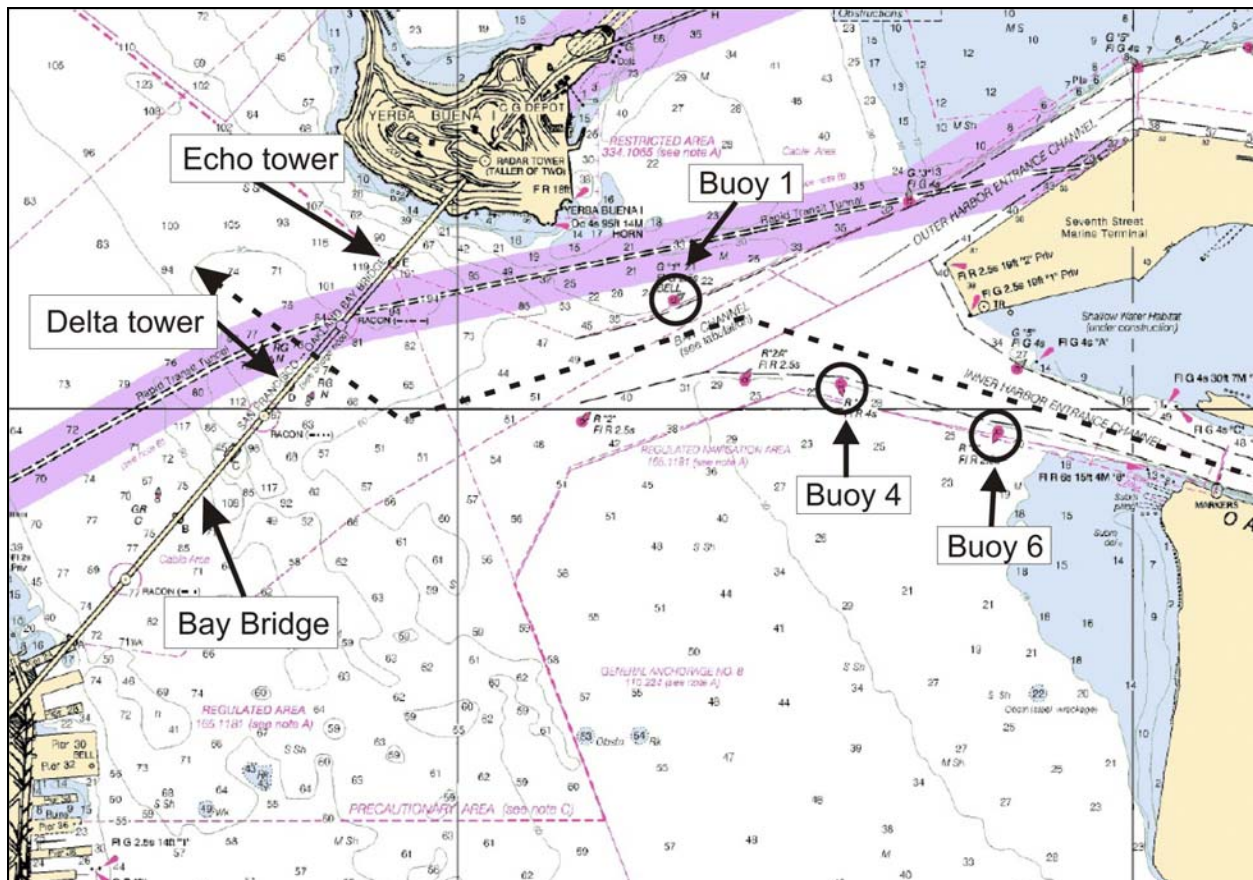
**Figure 3.** Navigation chart of the accident area with the approximate intended course of the *Cosco Busan* shown by the black dotted line.

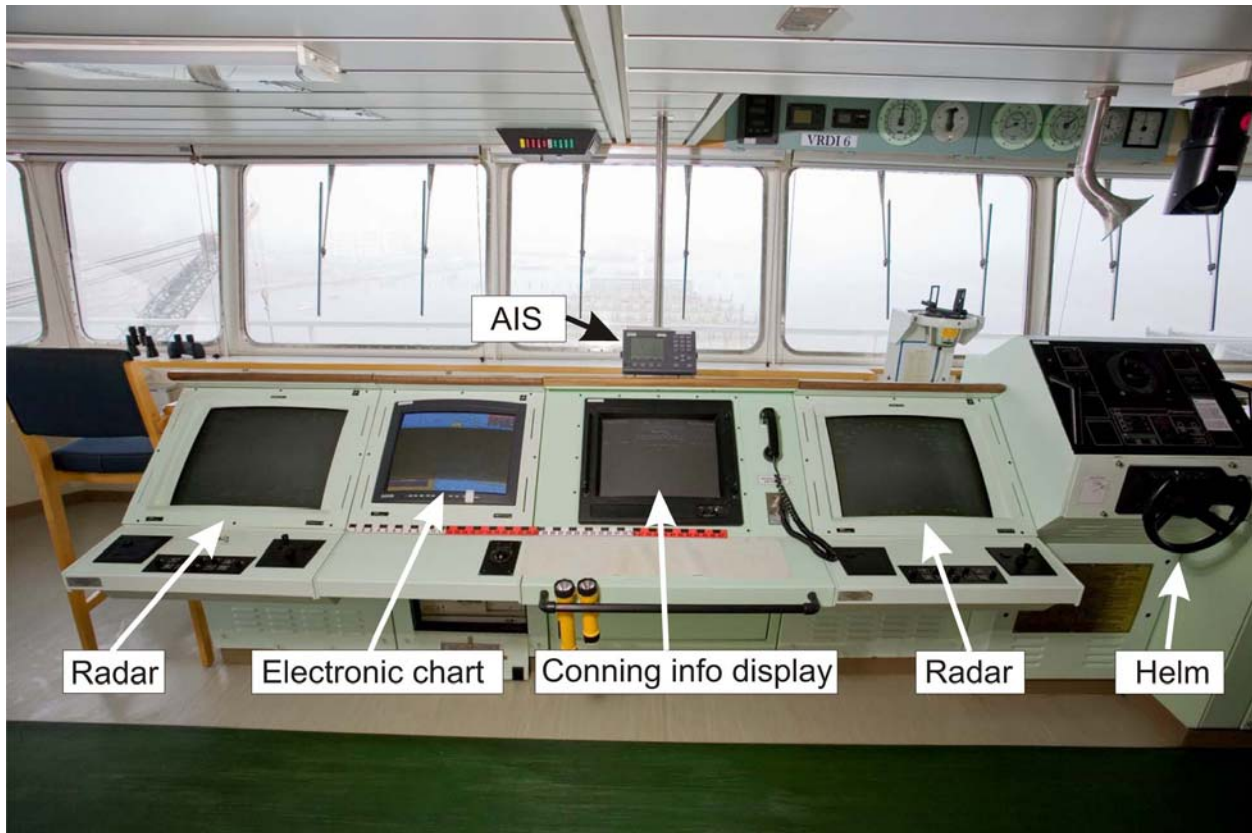
**Figure 7.** The bridge of the *Cosco Busan* showing primary navigation displays.

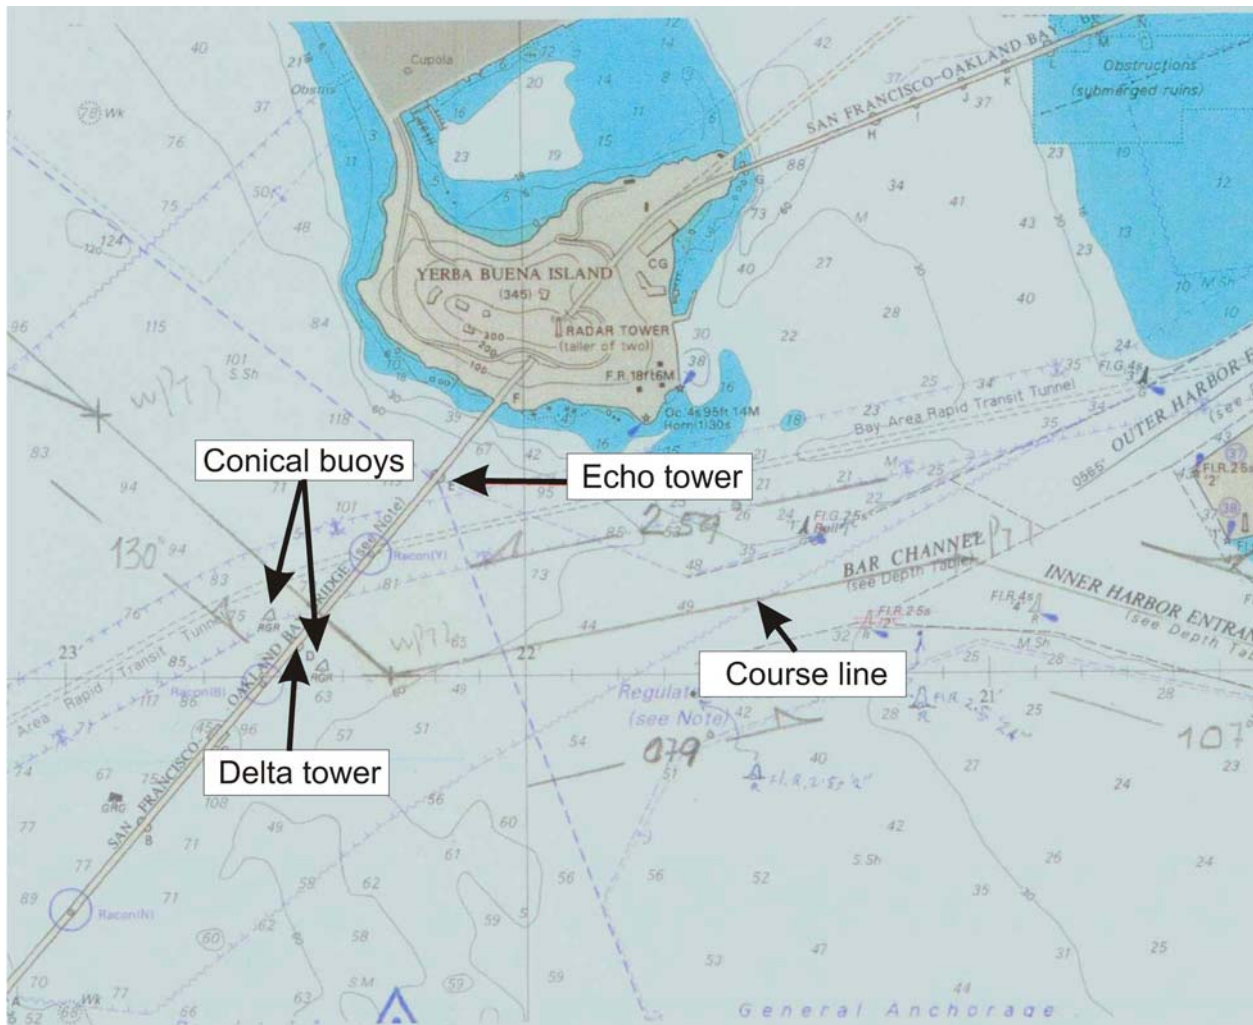
**Figure 10.** A portion of the paper chart that was on the chart table on the bridge of the *Cosco Busan* at the time of the allision. The course line, with in- and outbound headings, had been plotted and added to the chart by the ship's crew.

Before arriving in Oakland, a crewmember re-traced the previous crew's erased course line on the paper chart indicating the planned inbound route through the Delta–Echo span of the Bay Bridge to berth 56 (figure 10). The paper chart did not have a separate course line for the outbound route, but reciprocal headings on the single course line indicated that the same course could be used on the return to sea. Neither of the two VDR microphones in the area just to the left and right of the chart table picked up any conversation regarding the paper chart before the allision. Specifically, the pilot and the master were never heard talking about or referencing the paper chart until after the allision. Nor did the VDR capture any other conversation between the pilot and any other member of the bridge team referencing the intended route through the Delta–Echo span. In his postaccident interview, the pilot stated that he had not seen the paper chart.

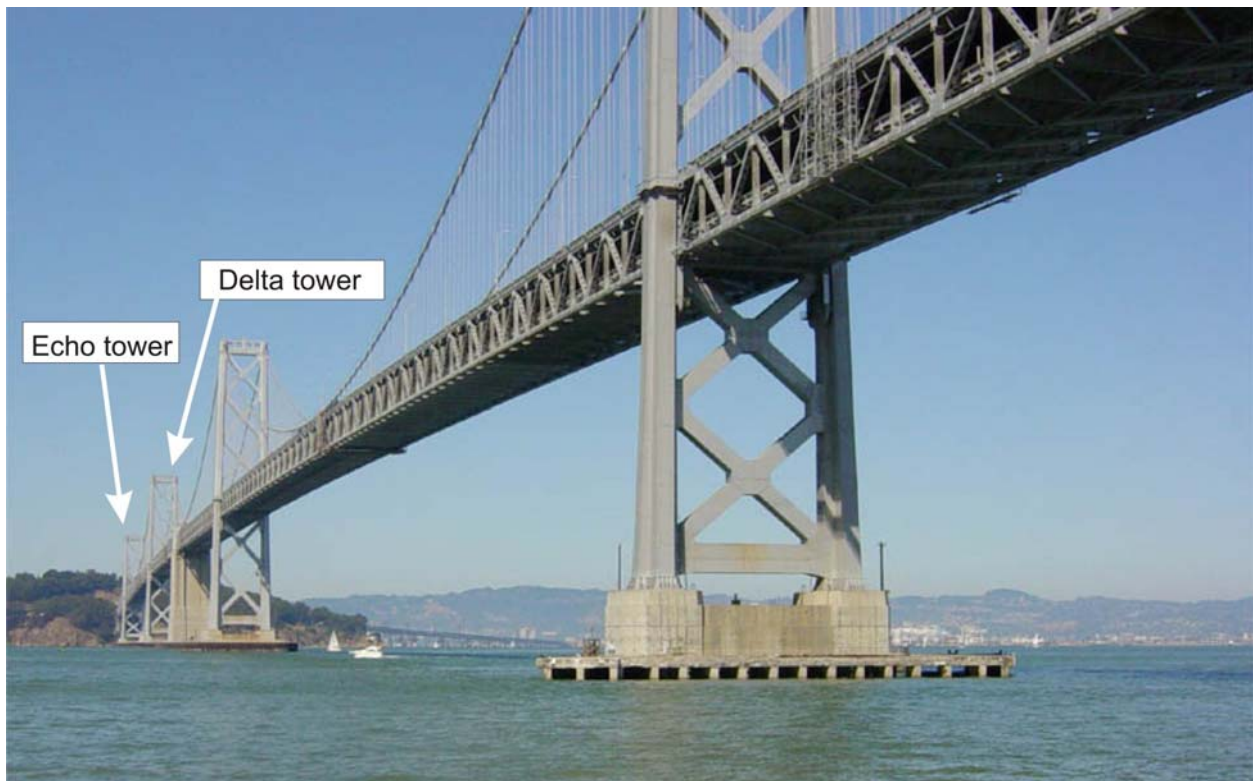
**Figure 11.** The western crossing of the San Francisco–Oakland Bay Bridge looking east.

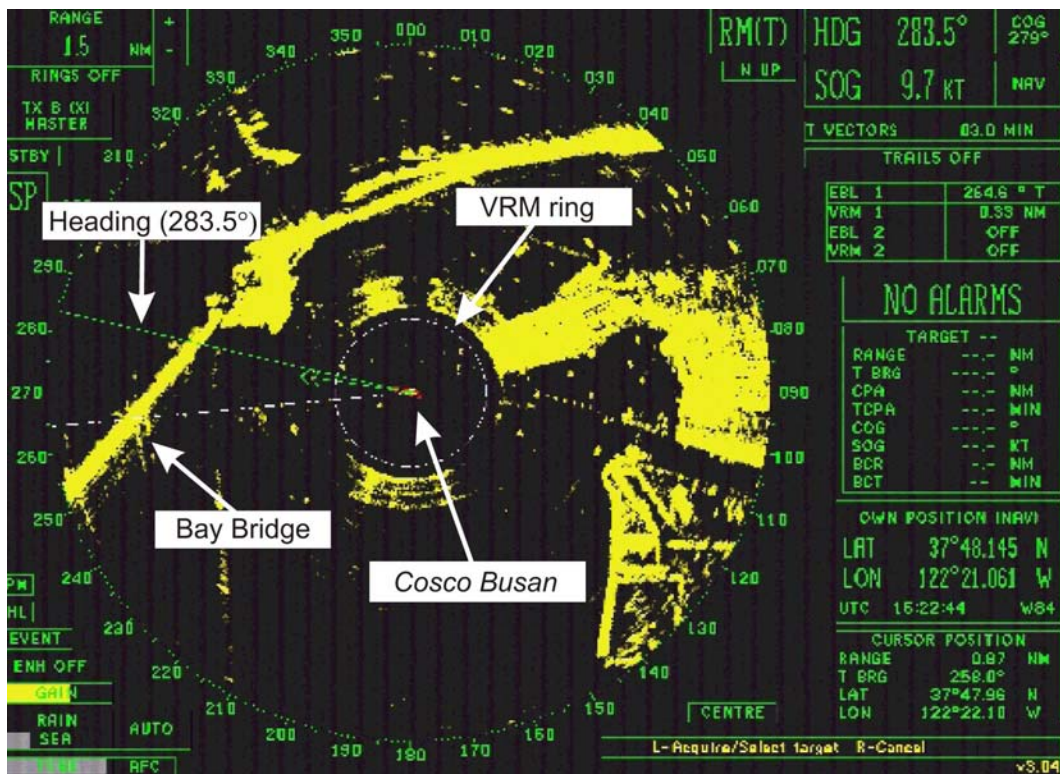
The *Cosco Busan* pilot told investigators that about the time the vessel began its initial turn to port (about 0823), “the radar picture of the bridge got distorted. It got wider. The bridge got wider. The RACON never appeared.” Investigators reviewed the radar images captured by the VDR and assessed the quality and consistency of the images that were displayed during the accident voyage (figure 13). This review revealed that the radar returns from the Bay Bridge did not change significantly from the time the bridge first became visible on the display about 0819 until about 0826 when the upper end of the bridge appeared to widen. The upper portion of the bridge appeared to widen on the radar image for about 1 minute before beginning to return to normal.

During the public hearing on this accident, the Sperry manager of product support and training reviewed the image and attributed the change in the bridge’s appearance to the *Cosco Busan* being almost abeam of the bridge at that point, with the top section of the bridge providing a much stronger radar return because the radar was “shooting . . . [radiofrequency] energy directly into the girders . . .” Figure 14 shows the radar image that was being displayed on the *Cosco Busan* at the time the radar image of the Bay Bridge became, in the words of the pilot, “distorted.” After about 2 minutes, the entire bridge began to appear thinner on the radar screen as the ship approached the bridge and more of its radar waves passed beneath the bridge instead of being reflected back. The signature of the RACON transponder at the midpoint of the Delta–Echo span also appeared on the radar screen at regular intervals throughout the voyage.

**Figure 13.** (Top) Radar image displayed on the bridge of the *Cosco Busan* at 0822:44, just before the vessel turned to port, and (bottom) the radar image at 0826:14, just after the vessel made the turn to port. In the bottom image, note the identifier for the RACON at the center of the Delta–Echo span of the bridge.

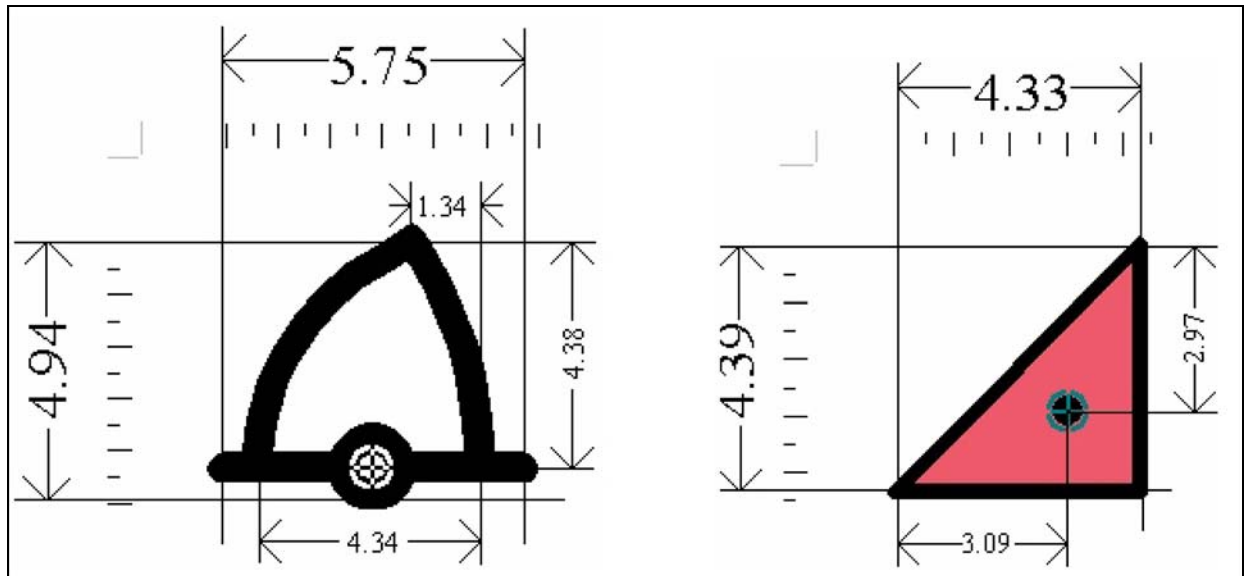
The electronic charts in use on the *Cosco Busan* were C-Map CM-93 vector charts. Although the vessel’s electronic chart system was not a certified ECDIS, the symbols used to signify conical buoys on the CM-93 charts were similar, if not identical, to the symbol for these buoys shown in the International Hydrographic Organization’s (IHO’s) *Presentation Library for ECDIS, Publication S-52, Appendix 2, Annex A*. The paper charts in use on the vessel also displayed conical buoys that appeared identical to those in the presentation library. Figure 15

shows the standard symbols for conical buoys used on IHO-compliant paper charts and on the CM-93 electronic charts (as well as on all ECDIS-certified S-57 charts).<sup>98</sup>

**Figure 15.** The International Hydrographic Organization (IHO) symbol used to represent conical buoys on paper charts (left) and the simplified symbol for the same buoys as represented, in red, on IHO S-57 electronic navigation charts (right).
