Marine Investigation Report
Accidental Release of Lifeboat
Bulk Carrier *Pacmonarch*
English Bay, Vancouver, British Columbia
26 October 2000

Report Number M00W0265

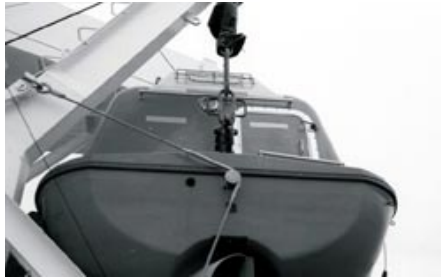
Photo 7. After bollard, gripe and hook lever on davit

During the initial part of the launch sequence, the davit's luffing action toward the ship's side causes the lifeboat to swing outward. As the davit draws away from its support frame, it creates an ever increasing gap between itself and the rigid frame. This gap frees the rotating lever, to which the davit end of the gripe is hooked, and allows the lever to turn and release the gripe.

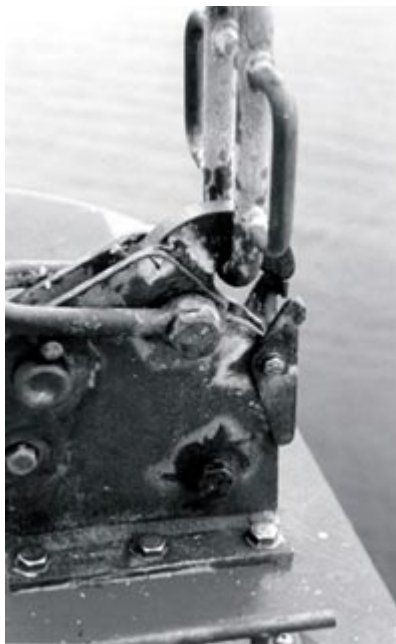
Photo 9. View of hook, suspension ring, and retaining latch

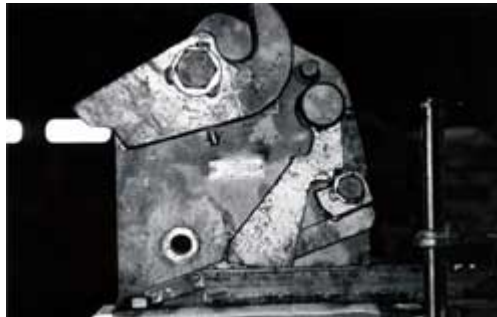
Photo 11. View of hook in open condition

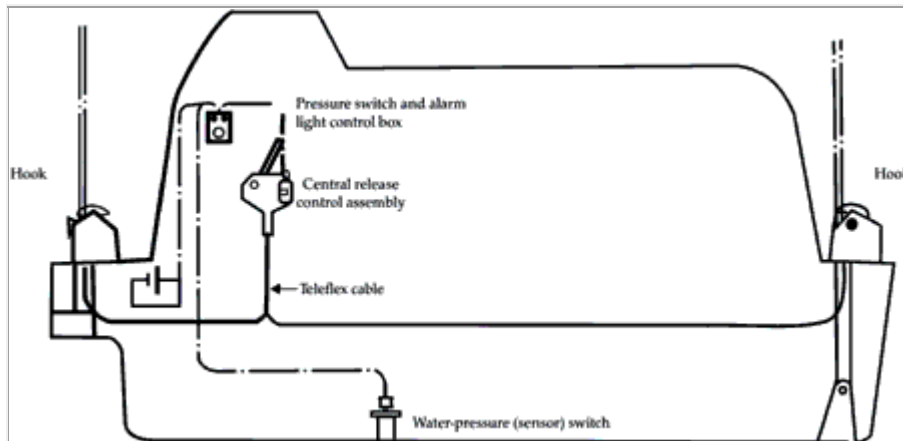
Figure 3. View showing connection between central release control assembly and hooks

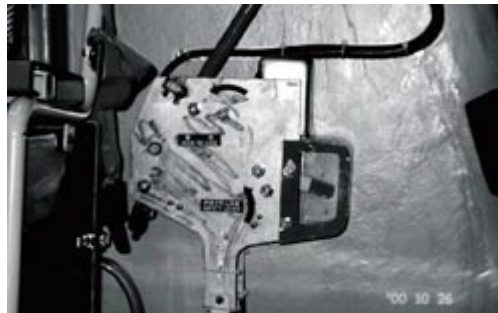
Photo 12. Central release control assembly.

The interlock lever, also shaped like a bell crank, turns about its own shaft but in the same plane as the release lever and the cable connection arms. A mechanical linkage connects the interlock to a solenoid coil above it; a return spring is connected to the interlock lever from underneath. The interlock lever can swing into, or out of, a position where it blocks the upward travel of the cable connection arms and, thereby, the release handle. The free end of the interlock lever is enclosed in a housing, one side of which is covered by a clear Perspex removable window that faces the operator. In an emergency, the operator can remove the window and manually lift the interlock lever away from its blocking position. According to the instruction manual, the frame around the perspex window is painted in two colours: the top half is red and the bottom part green. When inspected by the TSB, the entire frame was found to be painted red.

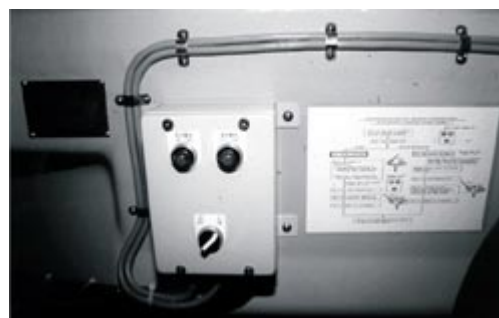
Photo 13. Indication panel

The lamps' indications are dictated by the contacts made between the cable connection arms, the interlock lever, and their respective microswitches. The positioning of these microswitches ([see Figure 4](#)), and the excessive play found in their sensing arms, allowed the panel lamps to falsely indicate the position of the interlock lever. When one or both of the cable connection arms were not being blocked by the interlock lever, the panel lights could incorrectly indicate that they were blocked.

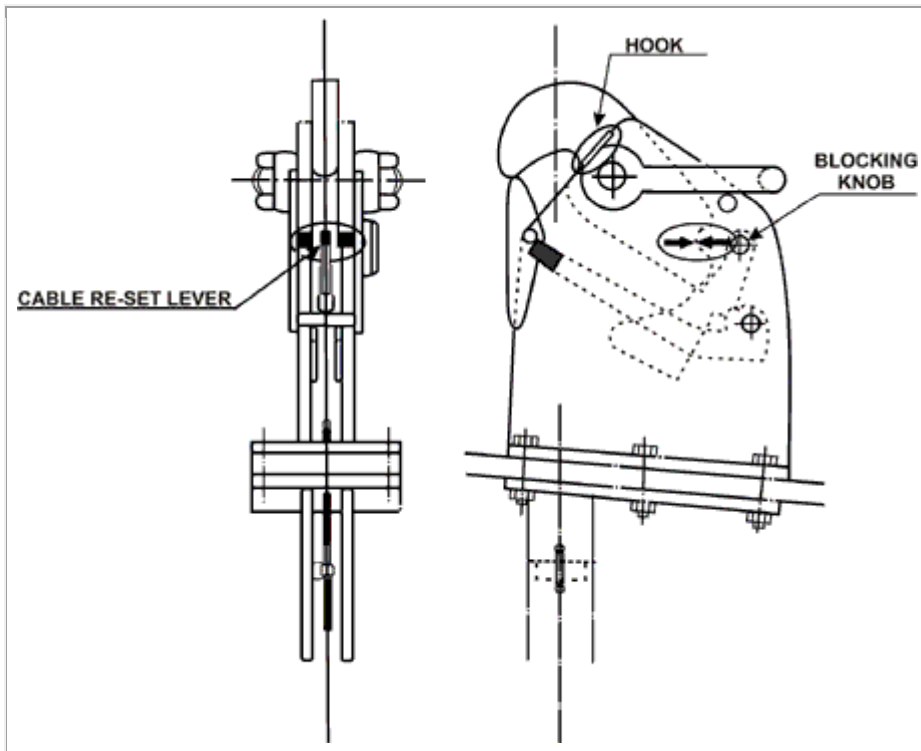
The TSB's post-occurrence inspection of the hook assemblies indicated that, in the reset position, the reference marks on the reset levers were not aligned with the reference marks on the cheek plates. The top surface of the mark on the reset lever was just below the bottom surface of the marks on the cheek plates ([see Photograph 20](#)).

Figure 5. Arrangements of reference marks on hook assembly

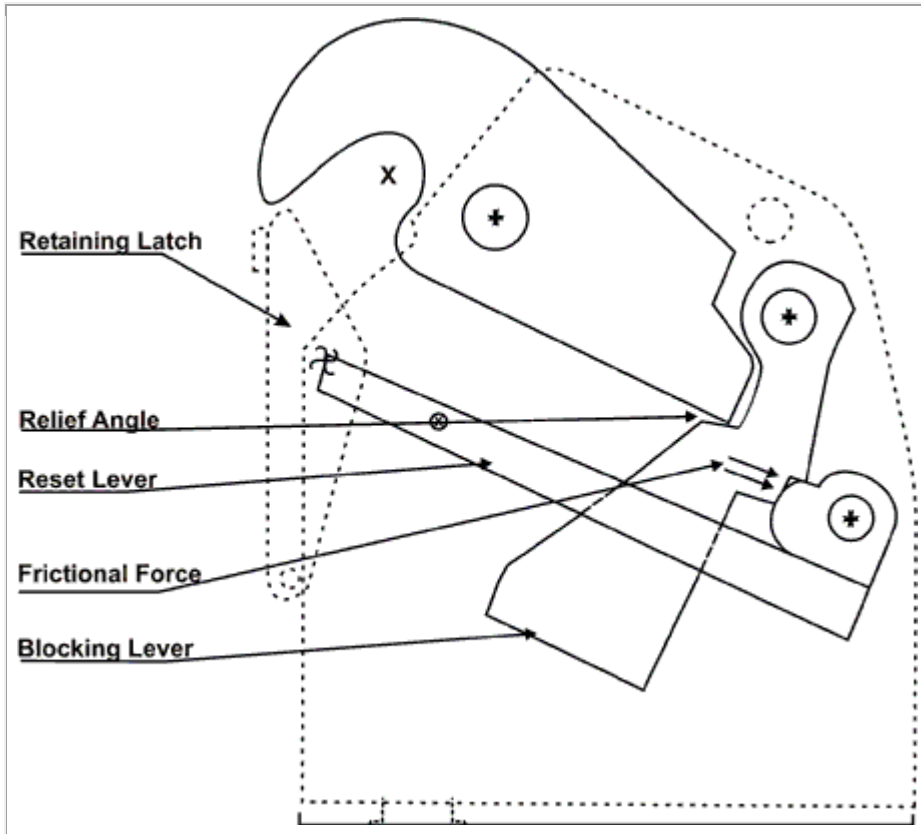
Figure 6. View of hook in load-bearing (reset) condition

The hook, the reset lever, and the blocking lever have been designed to rotate about pivots. To swing the blocking lever away and release the hook, the reset lever must first be moved out of the way. Since the reset lever moves in an arc, its contact surface with the blocking lever is also an arc. However, the corresponding contact surface of the blocking lever is planar, thus creating a line contact between these two surfaces (see Section 2.4.2). At its contact surface with the hook, the blocking lever has been given a relief angle of 18° . This angle also creates a line contact between them.

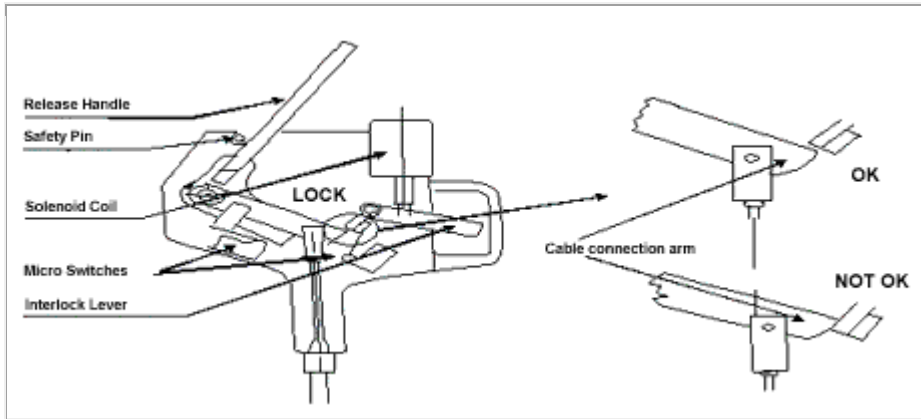
Figure 8. Internal schematic of central release control assembly

In case the lowering mechanism malfunctions, which could cause the lifeboat to become suspended from the falls, the hooks are also designed for an on-load release. In this case, the Perspex window in front of the interlock lever's free end is broken, and the interlock is physically lifted off the cable connection arms. The operator can now pull on the release handle to release the hooks and allow the lifeboat to fall to the water.
